# Gardenstown Landslide Newsletter – March 2018

## Landslide Development

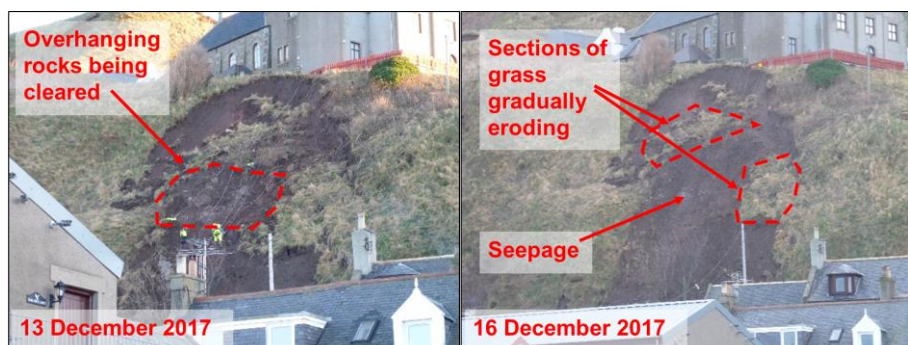
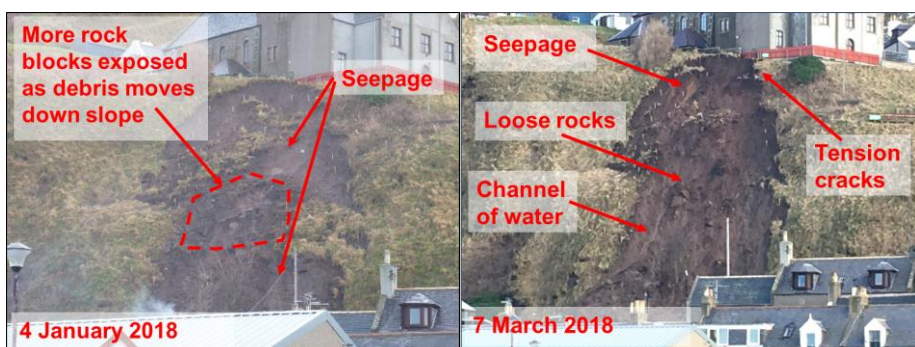
A landslide occurred overnight on 28 November 2017 in Gardenstown, which resulted in soil and rock debris being deposited on the B9123 Harbour Road. Since December 2017 the landslide has deepened into the slope, with material from the centre of the slope continually making its way to the toe. Following extensive wet weather, the landslide developed significantly on 6 March 2018, this resulted in the loose soil and rock debris mobilising, building up behind the temporary concrete blockwork wall at the toe and eventually causing the wall to topple.
