# **Carron Water Catchment Walkover**

**Final**

**2 April 2014**

**Aberdeenshire Council**  
Carlton House  
Arduathie Road  
Stonehaven AB39 2DP

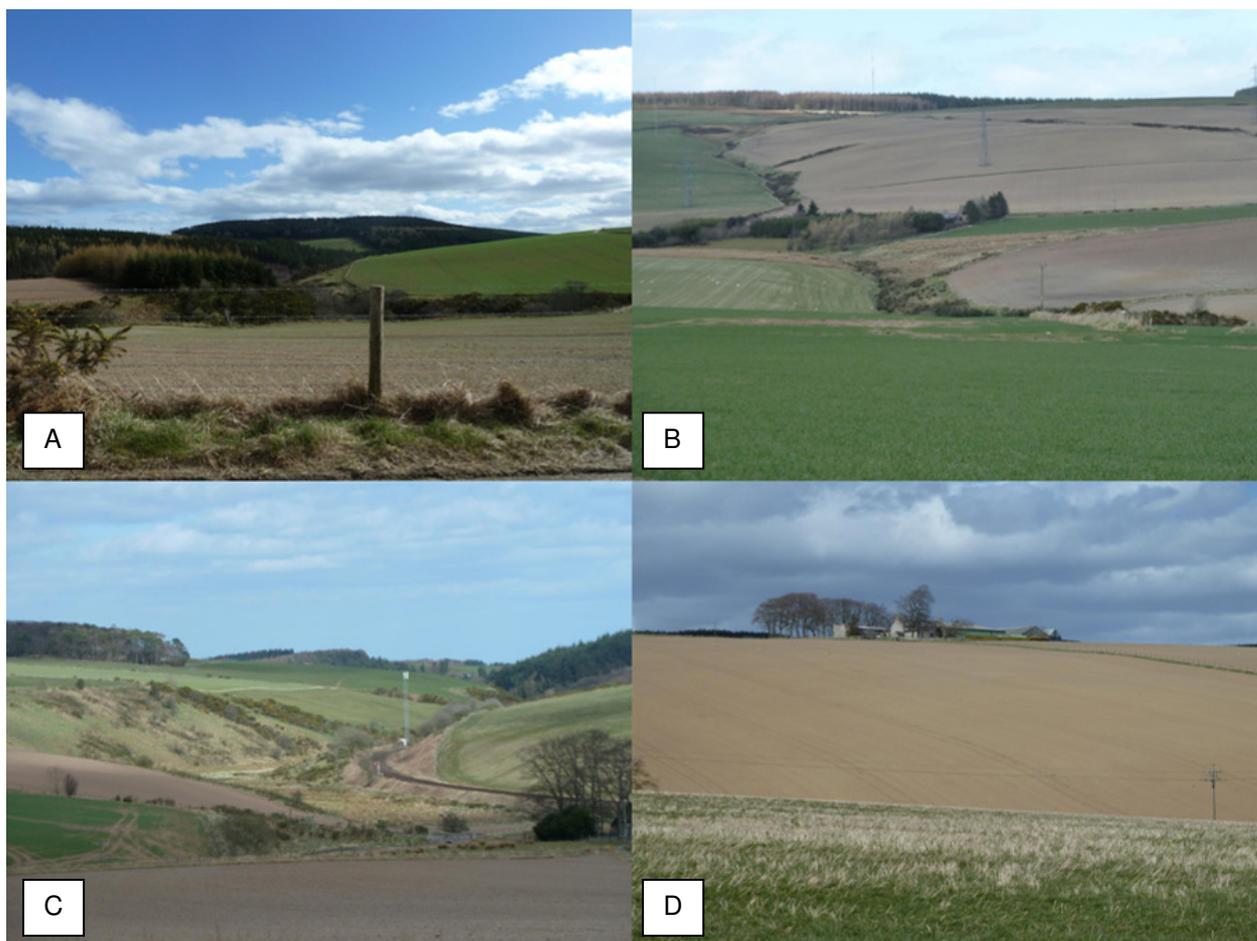
Figure 3-1: Carron Water upper catchment

Due to the time of year that the visit was undertaken there were a number of large fields which had recently been ploughed and hence were exhibiting bare soil conditions (Figure 3-1B & D). In some locations the impact of this on runoff generation is exacerbated through ploughing with the slope rather than cross contour ploughing (Figure 3-1D). Figure 3-1C shows some areas of confined floodplain on glacial terraces.

In these areas improve management techniques including contour ploughing and improved buffer strip provision, together with including increased vegetation variety and roughness along the channels edge are recommended. Buffer strips should be at least 5m in width. Gully woodland planting and cross contour shelter belt planting would also be beneficial in the upper

catchment. Opportunities also exist for the construction of leaky barriers at the edges of field to intercept overland flow where runoff is concentrated.

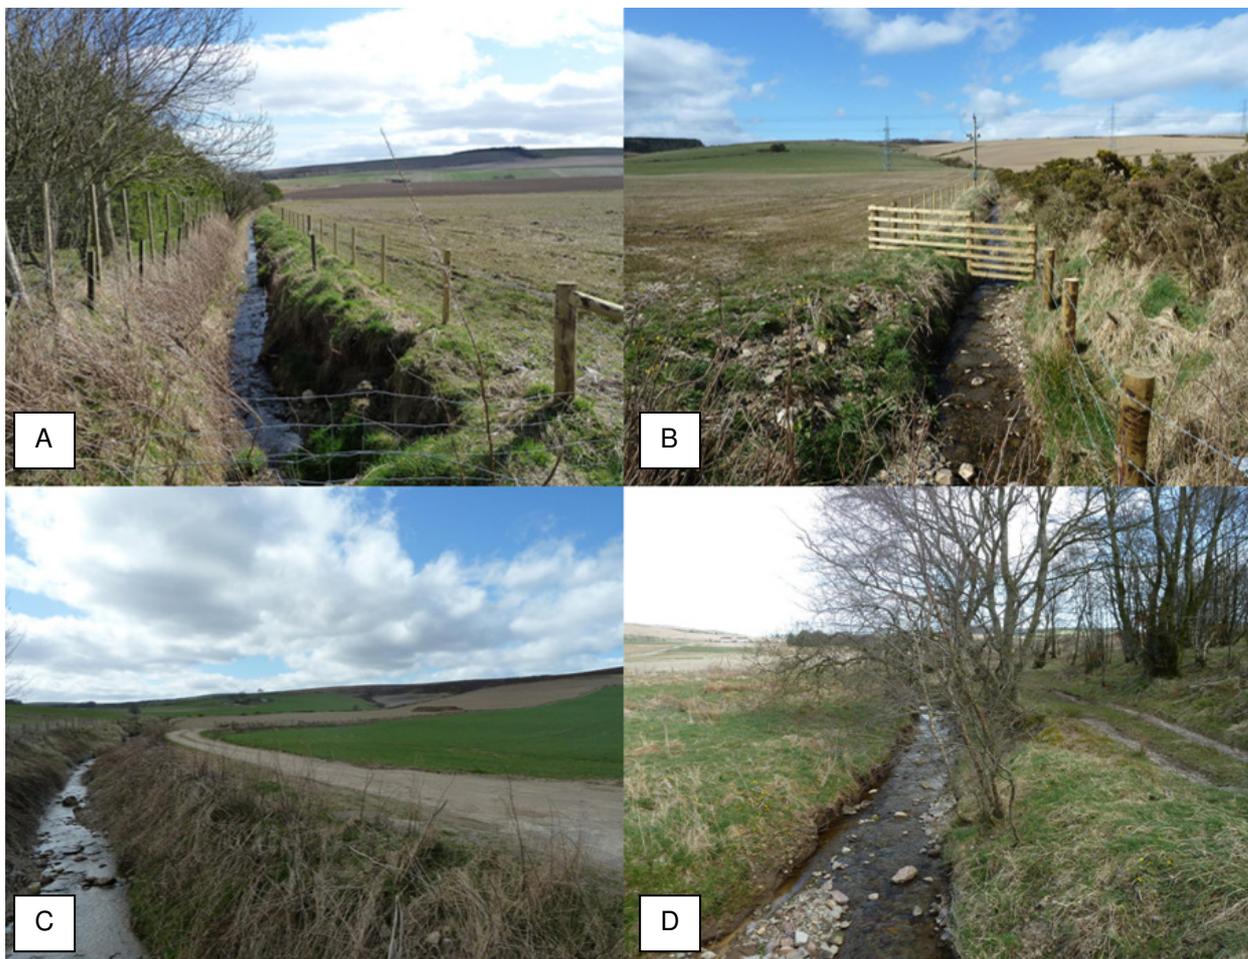
Figure 3-2: Carron Water upper catchment tributaries

Figure 3-2 shows typical tributary channels in the upper catchment of the Carron. These exhibit extensive straightening and in some locations over deepening (Figure 3-2C). In many cases buffer strips are non-existent and almost direct connection between the edge of the field and the channel exists, for example Figure 3-2B bottom left corner where soil and gravel is being mobilised into the river. Natural floodplain characteristics are minimal.

In these areas improved land and soil management techniques, including contour ploughing and improved buffer strip provision with an increase in vegetation variety and roughness along the channels edge, are recommended. Buffer strips should be at least 5m in width. Opportunities also exist for the construction of leaky barriers at the edge of field to intercept overland flow where runoff is concentrated. Reconnection of the watercourse with its floodplain through encouraging channel meandering would be beneficial where channels have been straightened and over deepened. This would create opportunities for large woody debris placement, river bank woodland planting, off-line storage ponds and channel restoration. In addition some off line storage – effectively a SuDs type pond could be constructed at the end of arable fields.

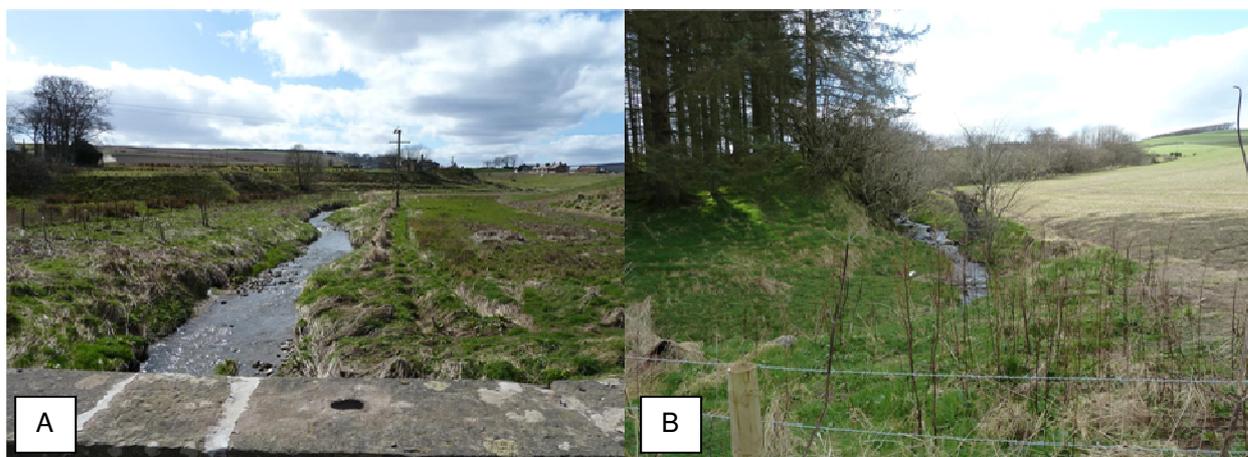
Figure 3-3: Carron Water mid catchment

In the mid catchment there are areas of floodplain confined between glacial terracing. These areas have been typically grazed (Figure 3-3A). Figure 3-3B shows typical agricultural land sloping towards the watercourse and limited buffer strip on the left bank.

The area shown in Figure 3-3A presents opportunities for the placement of large wood debris within the channel along with woody barriers or earthen bunds across the floodplain to retain water for longer on the floodplain. Opportunities also exist in this area for floodplain woodland planting.

Where the floodplain is narrower, such as shown in Figure 3-3B opportunities exist for the construction of leaky barriers at the edge of field to intercept overland flow where runoff is concentrated. Opportunities also exist for riparian woodland planting and channel restoration.

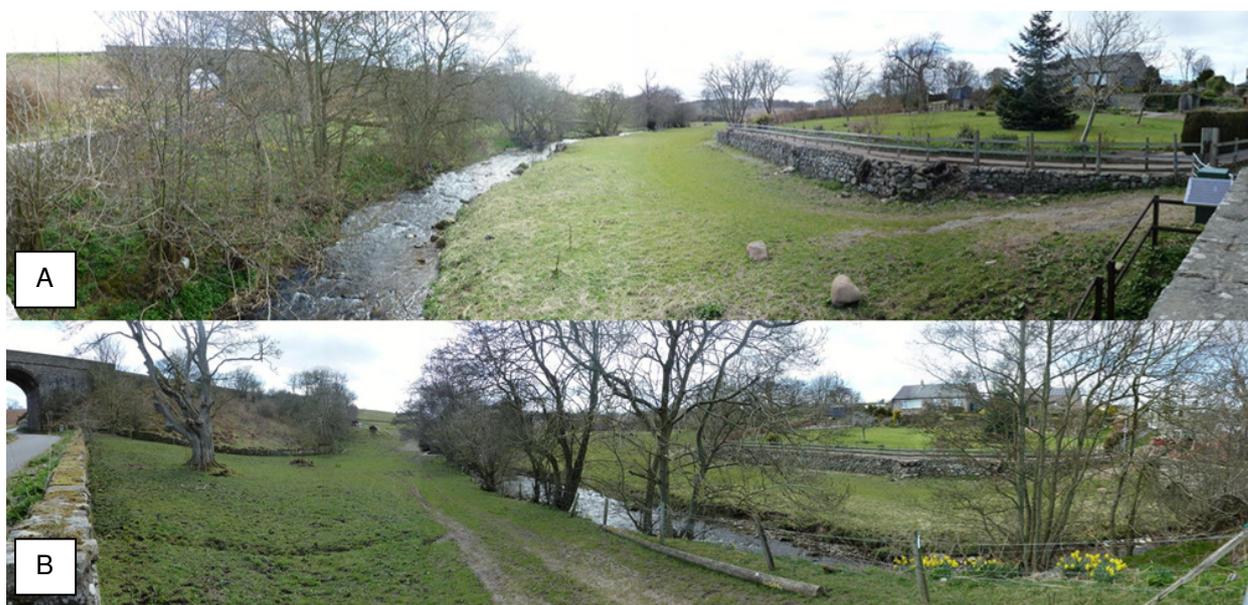
Figure 3-4: Carron Water Bridge of Fetteresso

As the Carron Water reaches Fetteresso and Bridge of Fetteresso the valley is much wider and is currently used as a horse paddock and grazing. As can be seen in Figure 3-4A & B the channel is tree lined with mature trees along the left bank, however vegetation cover consists of short grazed grasses up to the edge of the right bank. Man made features such as walls and garden terraces are prevalent.

In the area of Fetteresso Bridge floodplain opportunities exist for river bank woodland planting and improving the buffer between the grazed land and the watercourse. Fast flow pathways should also be intercepted. Where land is overgrazed reduction in grazing pressure should be considered and any accesses to the watercourse controlled to reduce poaching of teh river bank.

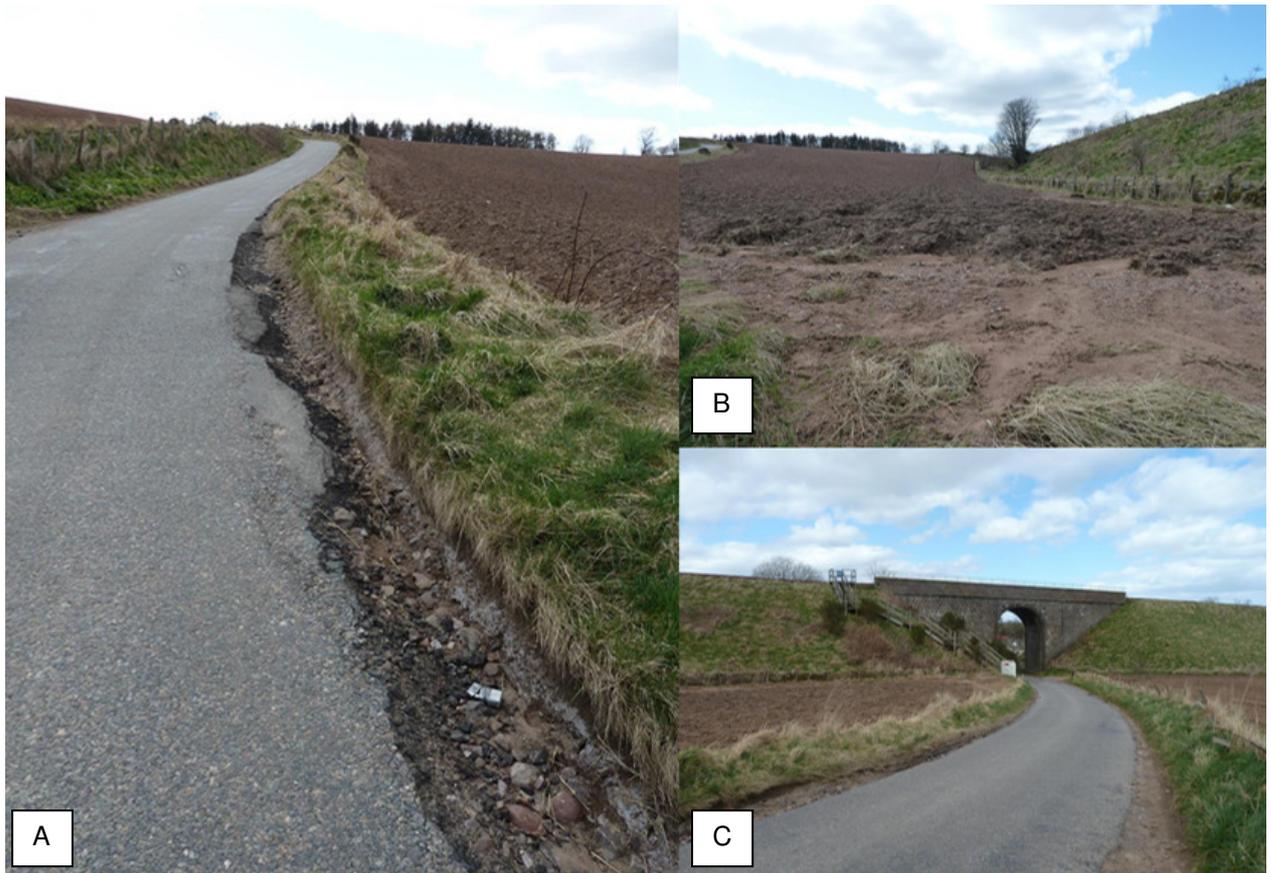
Figure 3-5: Carron Water near to Bridge of Fetteresso

The ground on the left floodplain rises steeply to the railway line. Beyond the railway line, the land continues to rise away from the railway line and hence watercourse. Figure 3-5A shows evidence of significant runoff over time eroding the edge of the road and creating a rill along the roads edge which is a fast flow pathway to the watercourse. Figure 3-5B is taken adjacent to the railway and looking upslope across a ploughed field, here significant volumes of fine sediments

have been deposited at the field's edge, resulting in water now running straight onto the road. Surface water was witnesses pouring from this location during the December 2012 event (see Figure 3-6).

Interception and disconnection of such fast flow pathways is needed in areas such as this (inc. runoff attenuation features). It is recommended that a leaky barrier / sediment trap is located at the corner of the field. Further investigation should also be given to runoff which is generated further upslope and running down the roads edge.

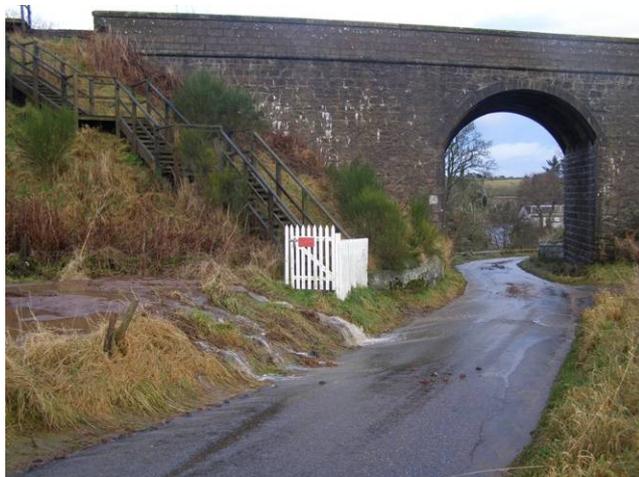
Figure 3-6: Photograph taken by SEPA during December 2012 event – note sediment and surface water flowing onto the road

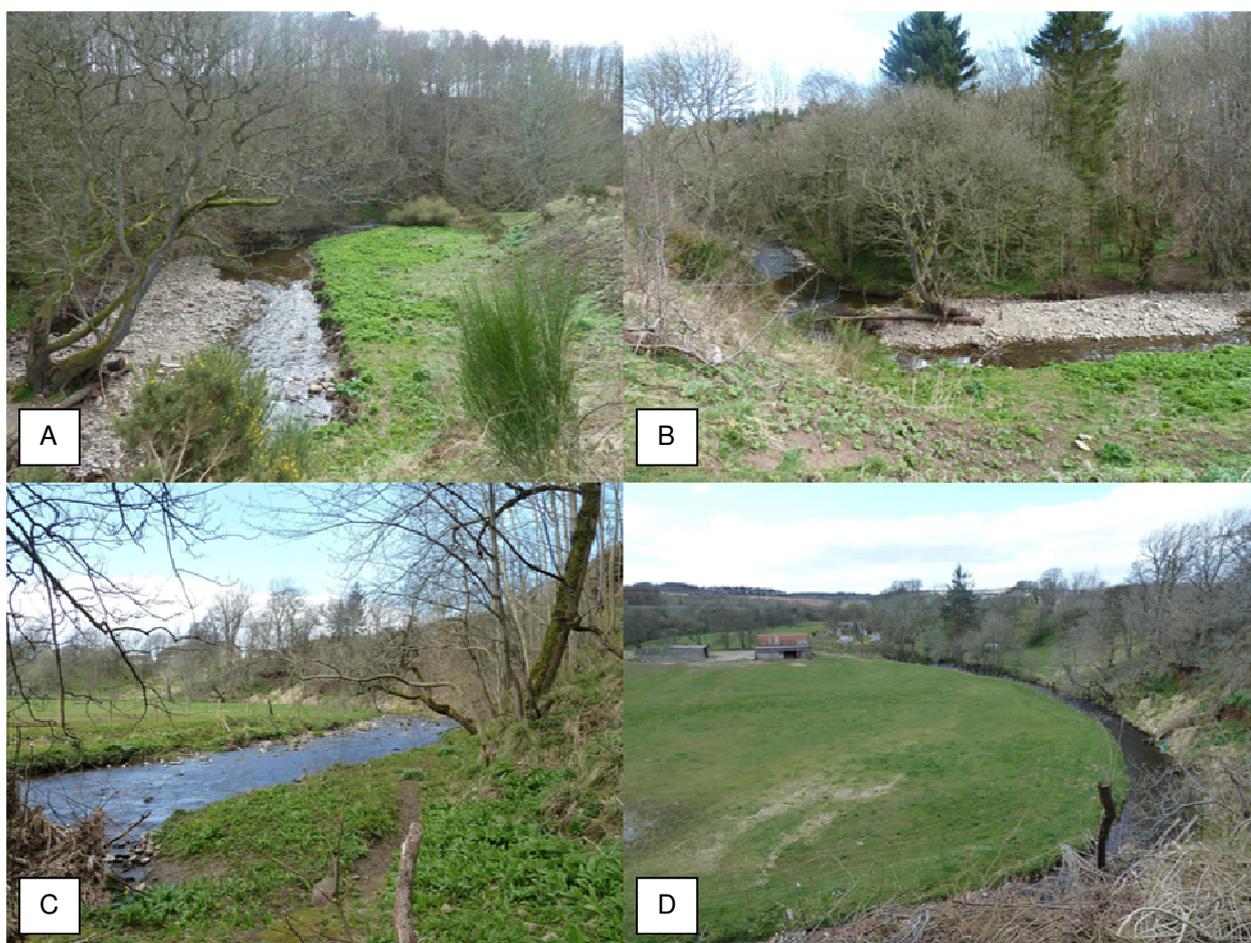
Figure 3-7: River Carron Deil's Kettle and Mill O'Forest Cottage

Immediately upstream of the main settlement of Stonehaven the channel flows beside Mill O' Forest Cottage and a high wooded glacial terracing confines the watercourse the along the left bank (Figure 3-7C & D). Residential areas of Stonehaven are located up high upon this terracing. The right bank and inside of this large meander is significantly lower and will act as floodplain during times of flood. This area has been significantly managed and grazed.

As the watercourse flows through the Deil's Kettle (Figure 3-7A & B), the right bank floodplain exhibits good examples of wet woodland floodplain. The extension of which should be encouraged onto the lower areas floodplain including areas such as that on the left bank shown in Figure 3-7A. There are also large gravel bars present

This wide area of floodplain would lend itself to the creation of a wooded floodplain and river bank area, including the encouragement of the watercourse onto the floodplain and the creation of backwater channels on the floodplain. Consideration should also be given to the construction of shallow earthen bunds (with simple piped outlets) – designed to allow both livestock and machinery to traffic over them without any problems but to hold water on the floodplain for longer.

Increase river bank woodland coverage through the Deil's Kettle. Monitor progress of gravel bars.

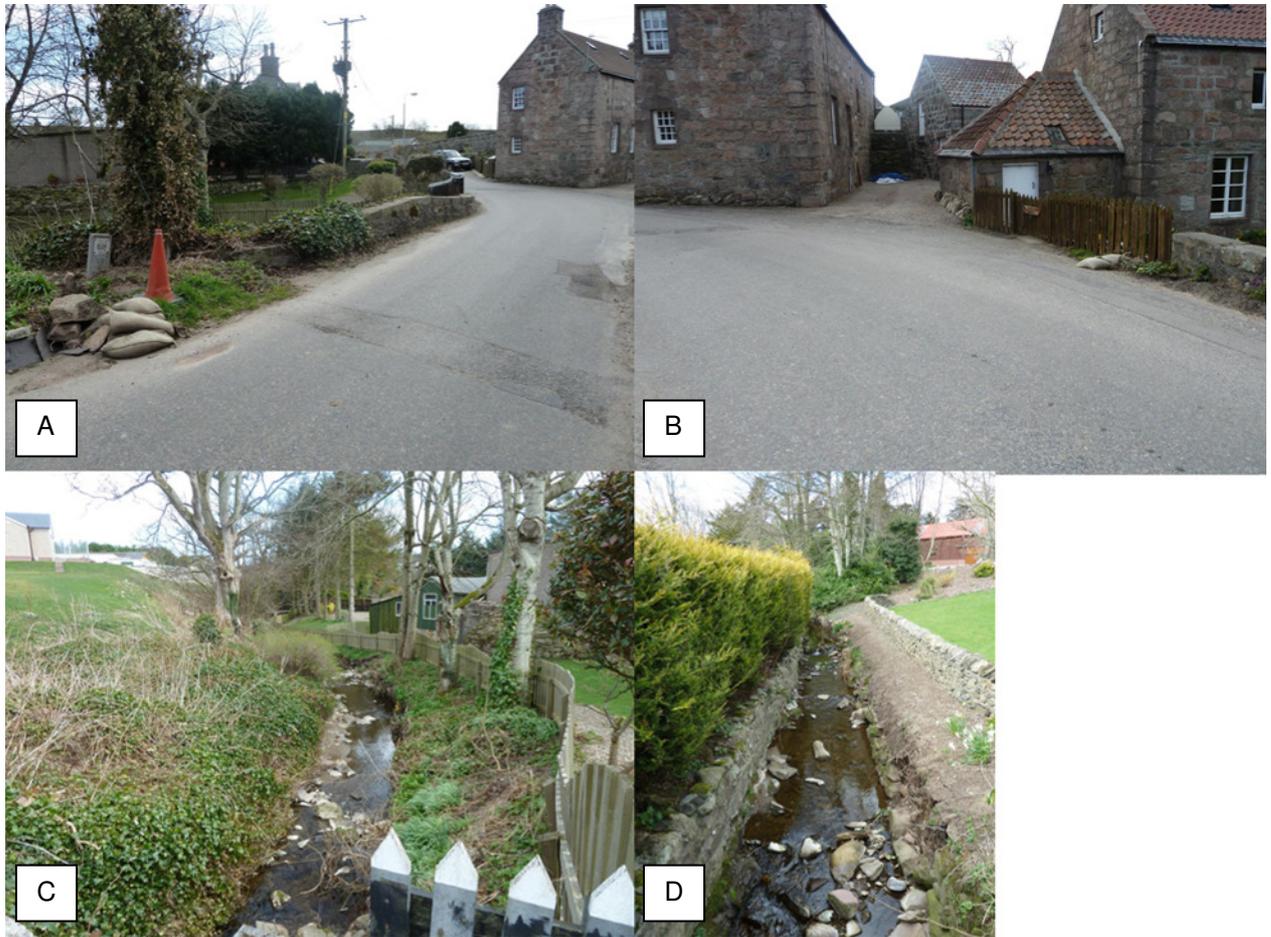
Figure 3-8: Cheyne Burn at Bridge of Fetteresso

The Cheyne Burn in the vicinity of the Bridge of Fetteresso has been historically straightened and presents limited floodplain connectivity as the watercourse has been canalised between garden walls (Figure 3-8D).

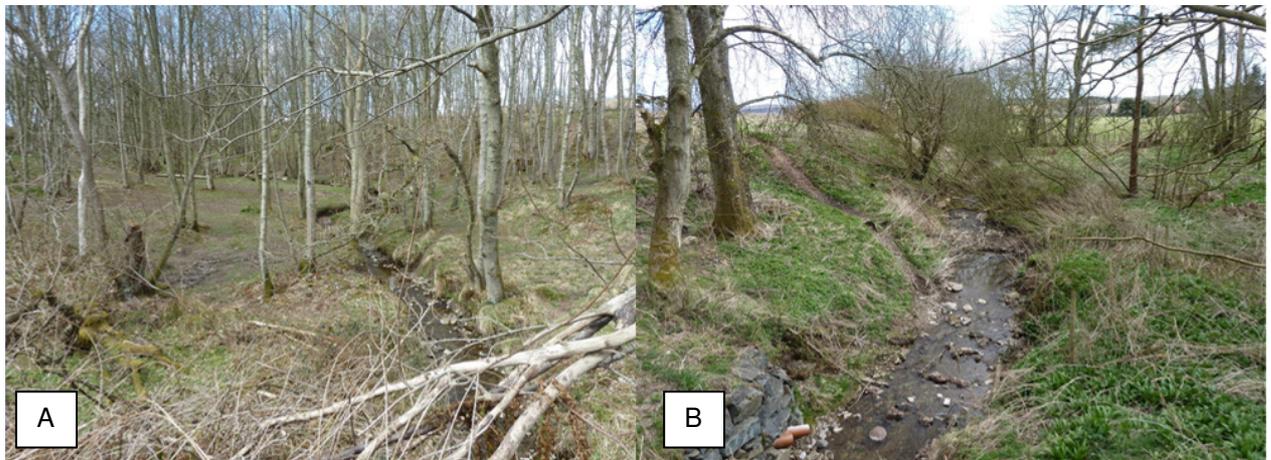
Figure 3-9: Cheyne Burn

Upstream on the Cheyne Burn there are examples of wooded floodplain which should be maintained (Figure 3-9A & B). Natural woody debris dams could be encouraged including the placement of artificial debris dams.

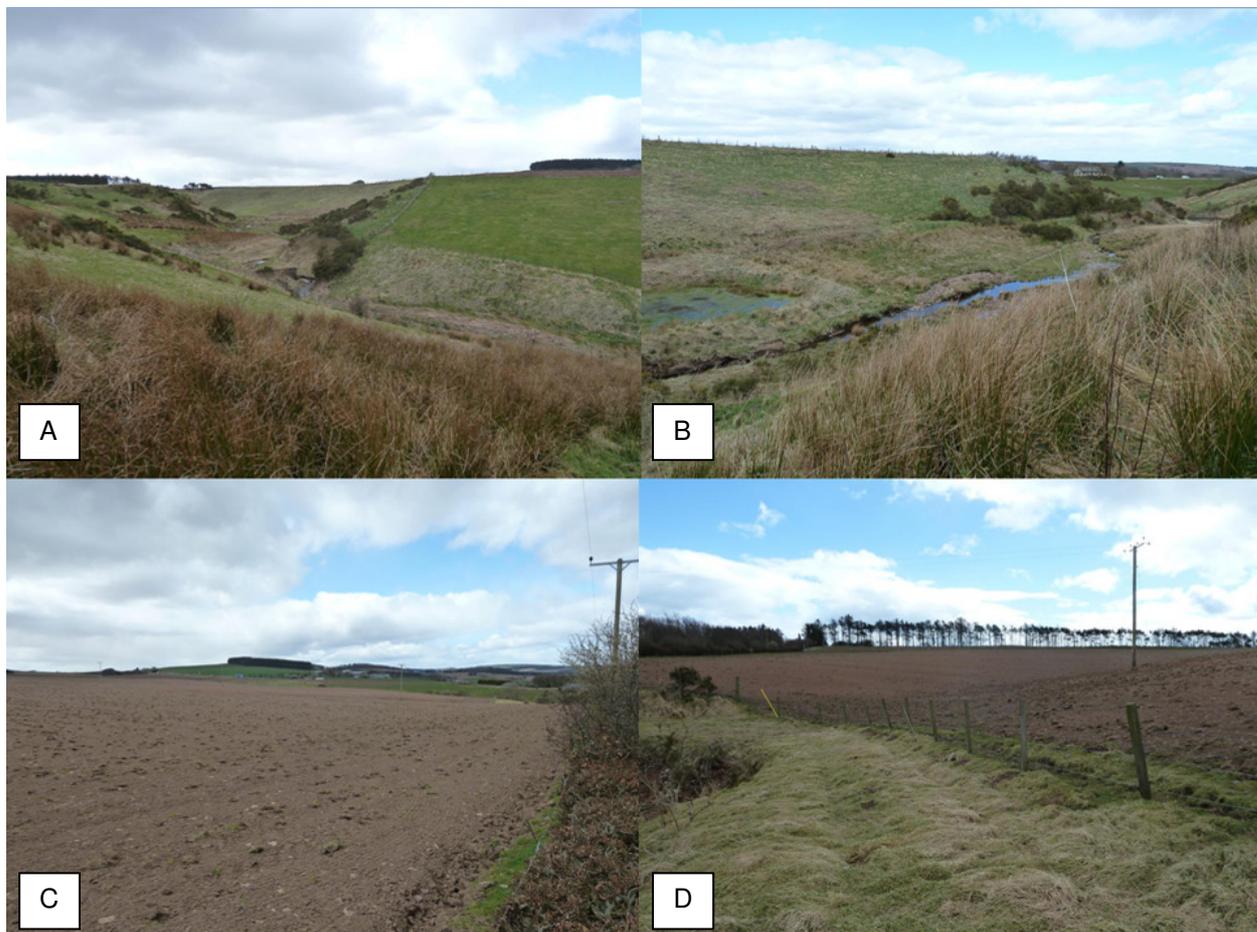
Figure 3-10: Glaslaw Burn Upstream of Stonehaven

The Glaslaw Burn is also impacted by land management, including over grazing and large field systems.

Extensive floodplains are not present on this catchment upstream of the A92 road, with confined gully / confined valleys being predominant. In addition Figure 3-10B shows existing farm wetlands on areas of floodplain which already exist.

In these areas improved land and soil management techniques, including contour ploughing and improved buffer strip provision with an increase in vegetation variety and roughness along the field-channels edge, are recommended. This is particularly important as significant overland flow was reported in the last flood.

Gully / valley woodland planting is evident and consideration of extending this tree planting on the floodplain should be considered.

The restriction of grazing on the floodplain and encouragement of vegetation diversity (e.g. more woody and stiffer tussocky material) on the floodplain are recommended. The introduction of large woody debris within this reach upstream of the A92 would encourage flow out onto the floodplain.

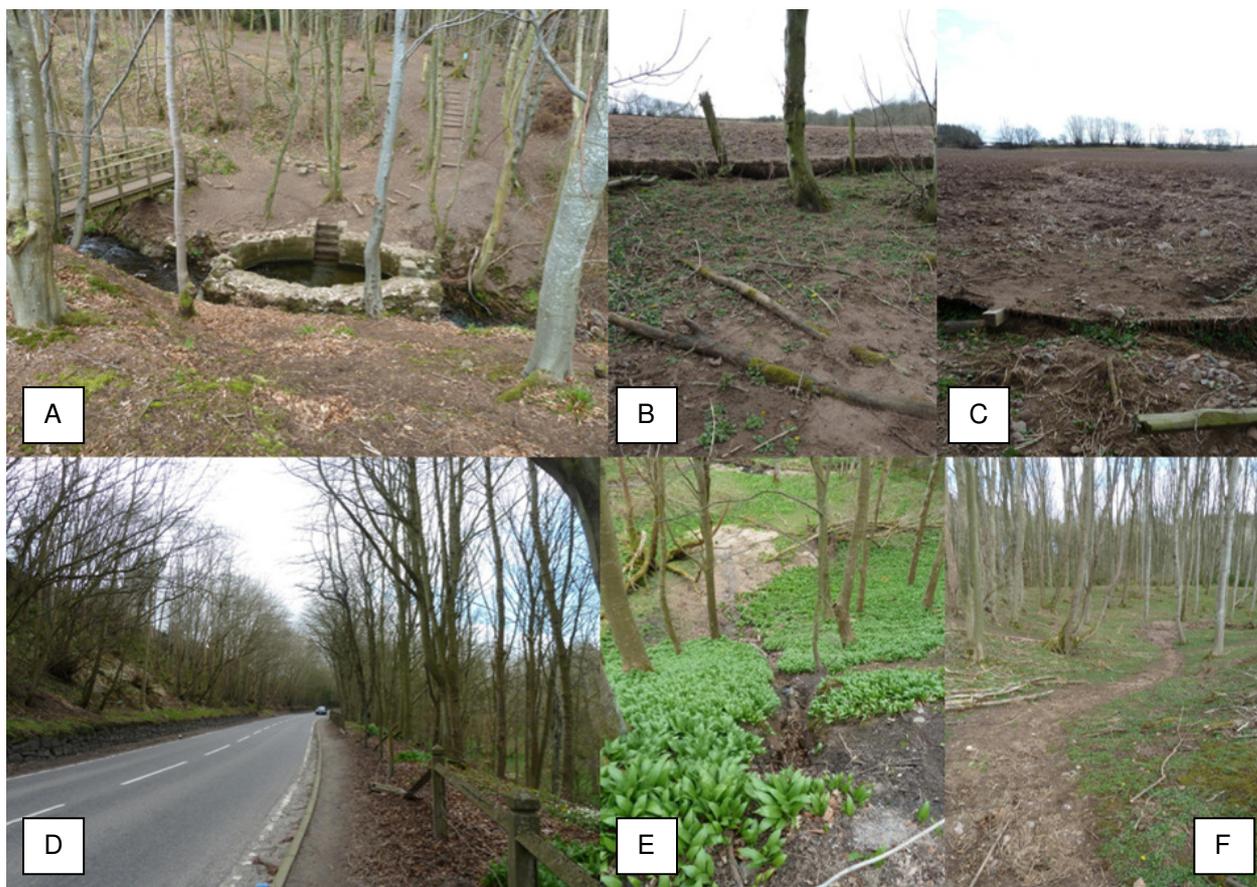
Figure 3-11: Glaslaw Burn Woods of Dunnottar

Downstream of the A92 road, the Glaslaw Burn enters the Woods of Dunnottar. This area of woodland acts as an ideal buffer to runoff from surrounding areas; however, there are locations where land management practices could be improved.

The land to the south of the Glaslaw Burn is located upon glacial terracing which then slopes steeply down to the watercourse. Figure 3-11B, C and F show significant sediment loss and rill formation on farm land on the terrace adjacent to the Woods of Dunnottar. Sediment can be seen building up against the boundary of the field and then flowing down into the Glaslaw Burn connecting directly with the watercourse and its floodplain. The A957 road also runs parallel to the Glaslaw Burn; with Figure 3-11D and E showing that road drainage is directly connected to the floodplain. The A957 road is steep and likely to pass high volumes runoff during times of intense rainfall.

Opportunities for improved management on the land adjacent to the woodland would assist with both reductions in runoff and reduction in the loss of sediment/ nutrients from the farmland (which in turn would reduce sediment inputs into the Glaslaw Burn and Carron Water. The locations shown in Figure 3-11B, C and F are ideal locations for the construction of runoff attenuation features such as a leaky barrier and sediment trap on adjacent land. The general lie of the land such as gradients, depressions and flow pathways will determine what runoff attenuation feature(s) might be appropriate. Where flow pathways through the woodland are evident woody debris dams should be encouraged to slow and dissipate runoff. Consideration should also be given to the disconnection of the road drainage to areas where increased infiltration into the soil could be encouraged.

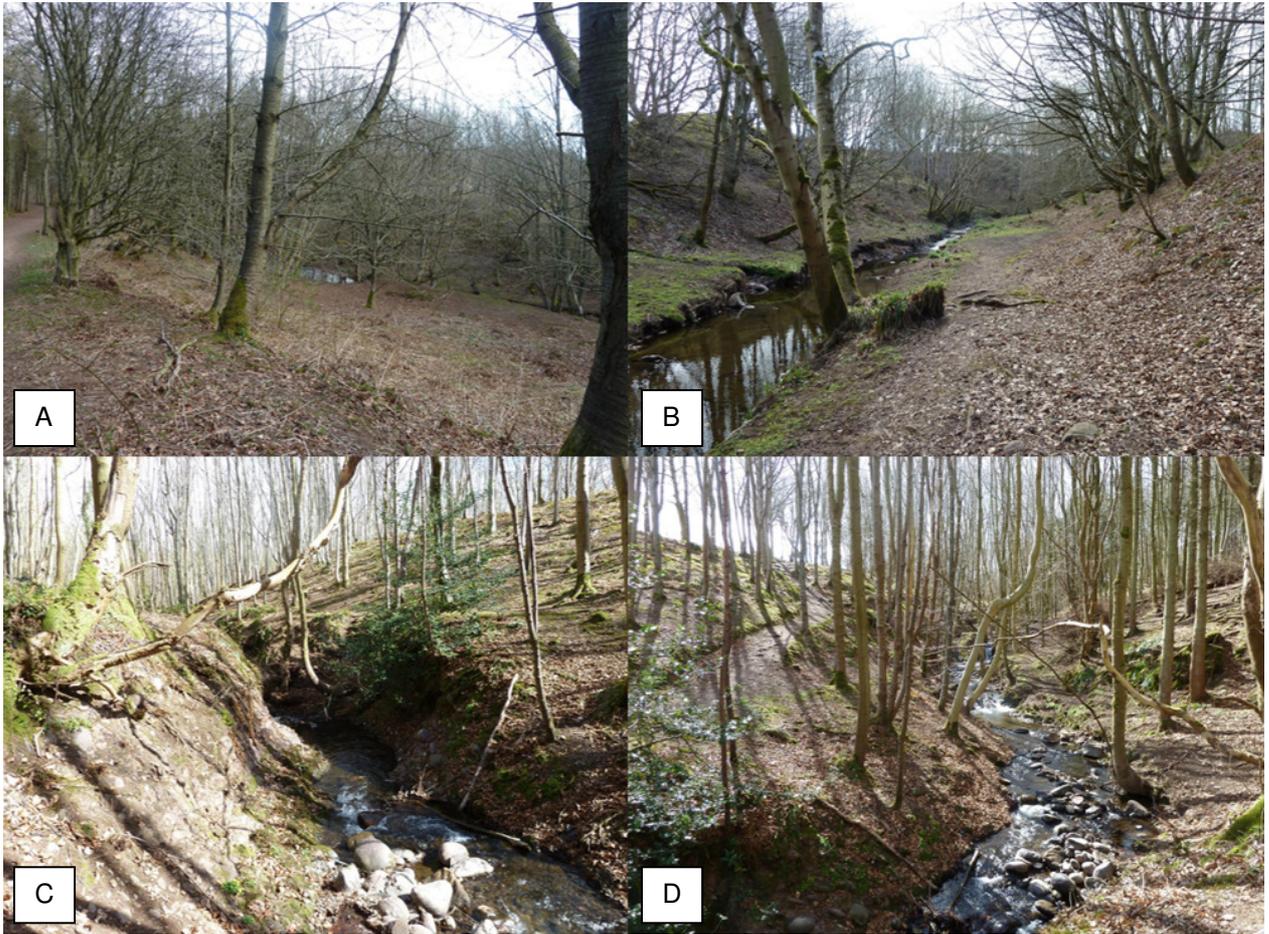
Figure 3-12: Glaslaw Burn Woods of Dunnottar

Immediately downstream of the A92 road culvert the Glaslaw Burn is well confined within limited floodplain extents.

Trees extend down to the water's edge and this should be maintained. The introduction of woody debris dams within the woodland should be considered.

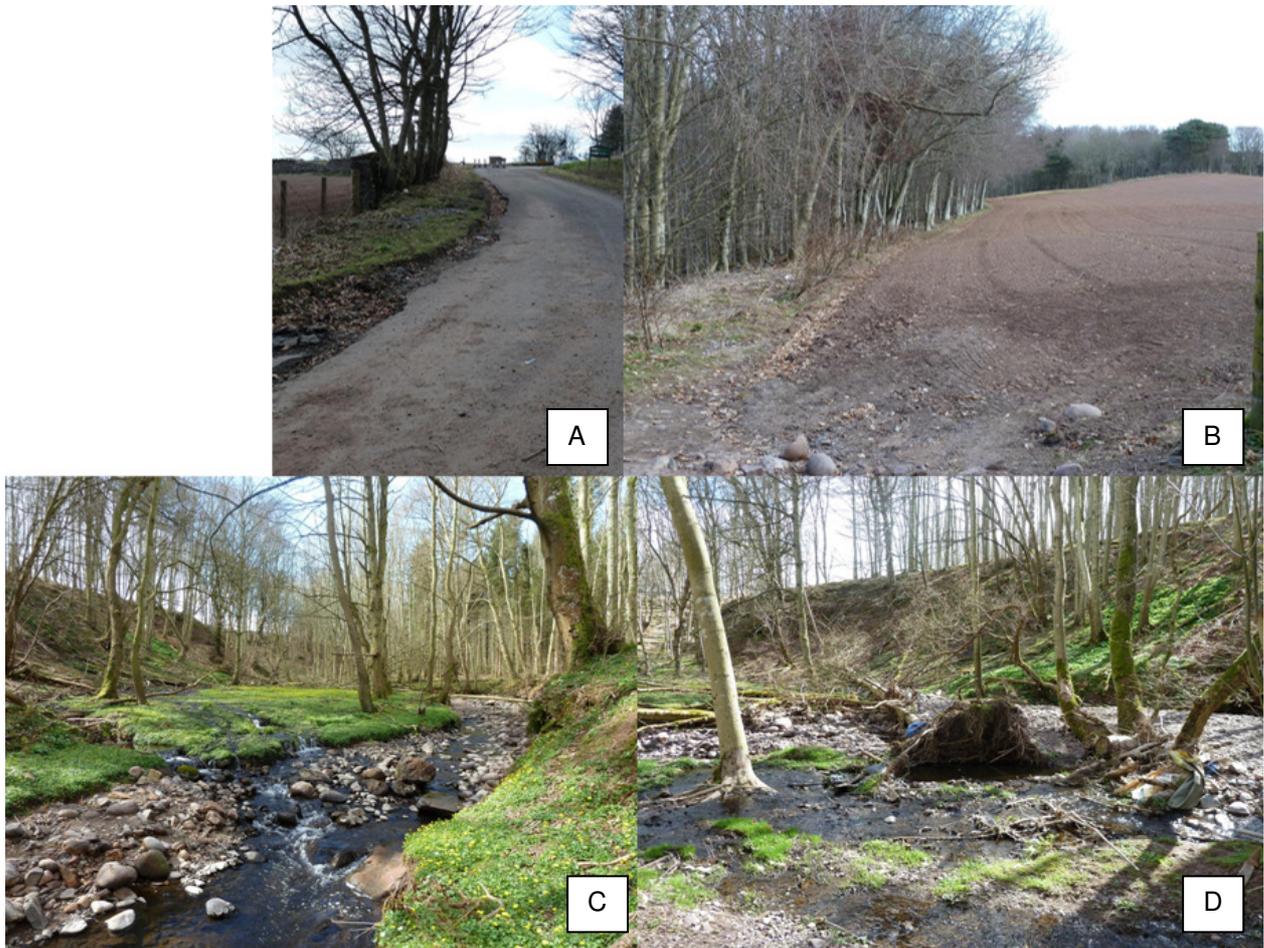
Figure 3-13: Glaslaw Burn Woods of Dunnottar

Figure 3-13 A and B were taken adjacent to the Dunnottar Church road culvert which experienced significant scouring during the December 2013 event. Runoff was clearly concentrated along the unclassified road and its verge.

Leaky barriers and sediment traps would be recommended in the fields to the south of the unclassified road, but also within the field edges where runoff is concentrated adjacent to the wood (for example Figure 3-13B). Where there is obvious overland flow from the edge of the fields consider low bunding and storage.

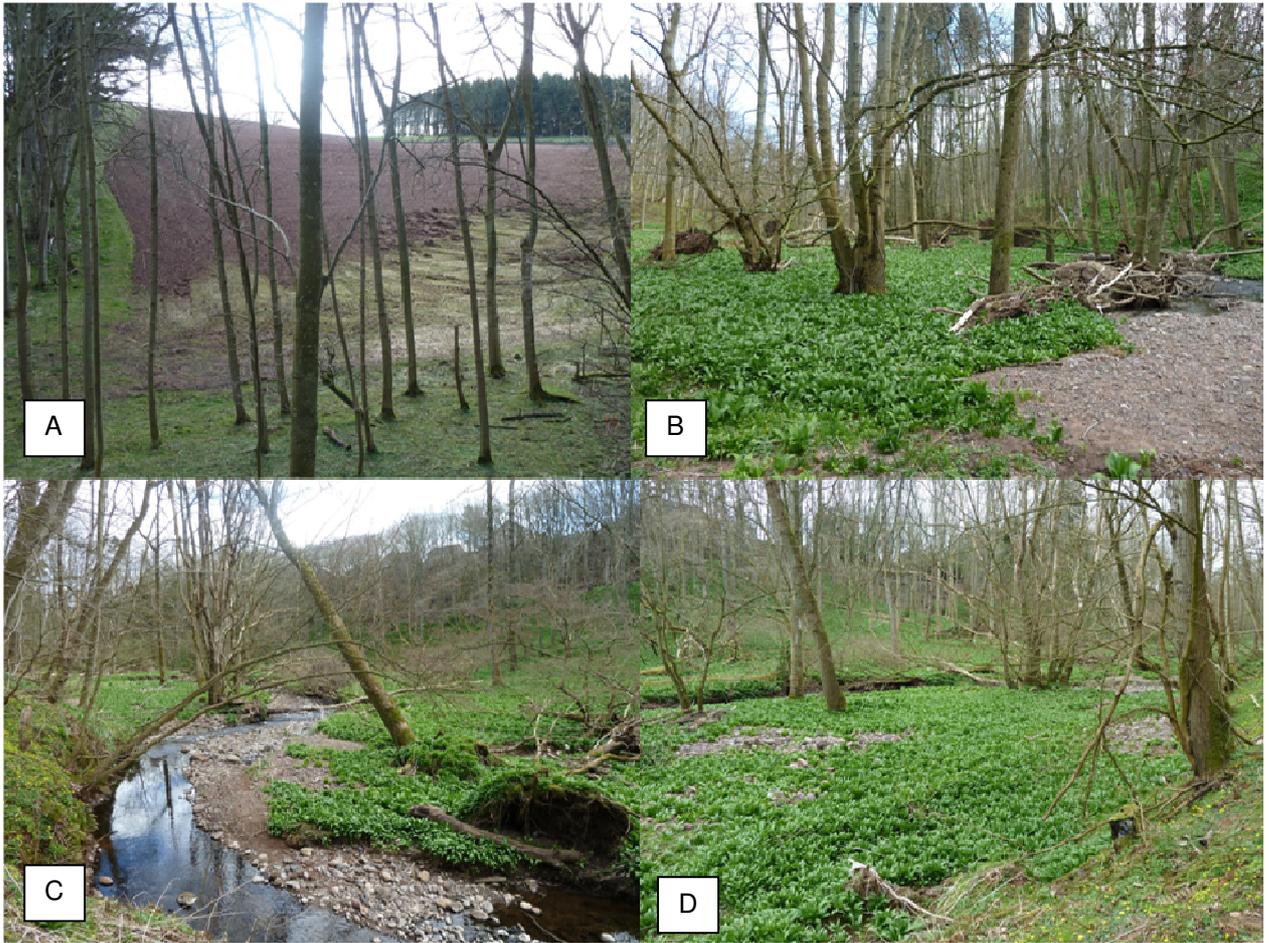
Figure 3-14: Glaslaw Burn Woods of Dunnottar, Downstream of Dunnottar Church Road.

As the Glaslaw Burn nears Carron Gardens the valley floor and hence floodplain widen significantly, with the entire floodplain showing evidence as having been active during the flooding in December 2012, including deposition on the floodplain, excellent examples of natural woody debris and channel activity (Figure 3-14,B C & D).

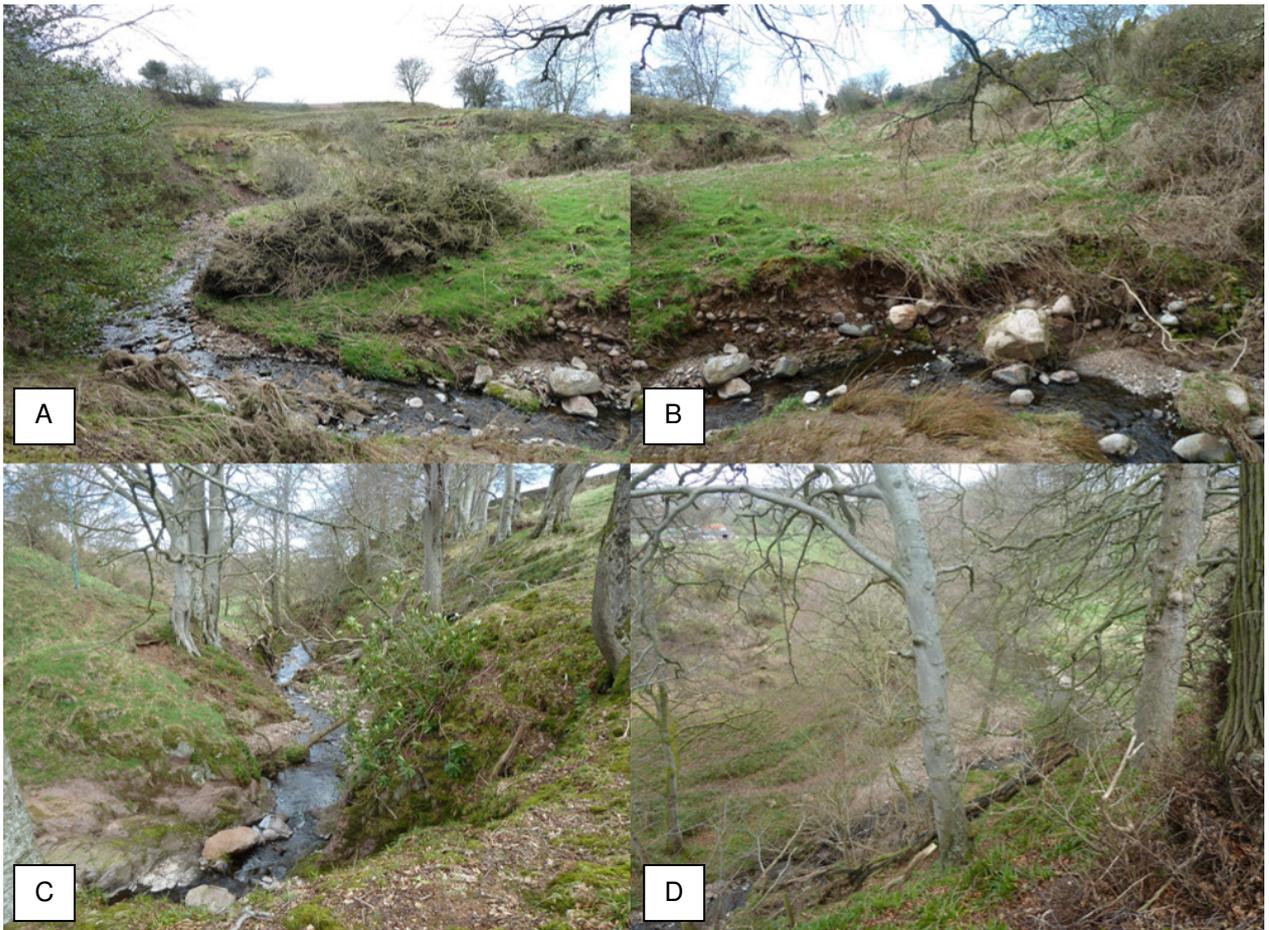
Figure 3-15: Toucks Burn Upstream of Confluence with the Carron

The Toucks Burn originates to the west of the A90 and flows into the Carron Water downstream of the Mill O' Forrest floodplain. The Toucks Burn has a steep gradient and active bank erosion is event as the burn passes the Dunnottar Church. Deposits of sediment have been caused to drop out onto the floodplain at the confluence with the Carron Water (Figure 3-15D taken in the vicinity of the Dunnottar Church).

Channel instabilities should be monitored on the Toucks Burn. Consider riparian fencing and planting to stabilise eroding banks.

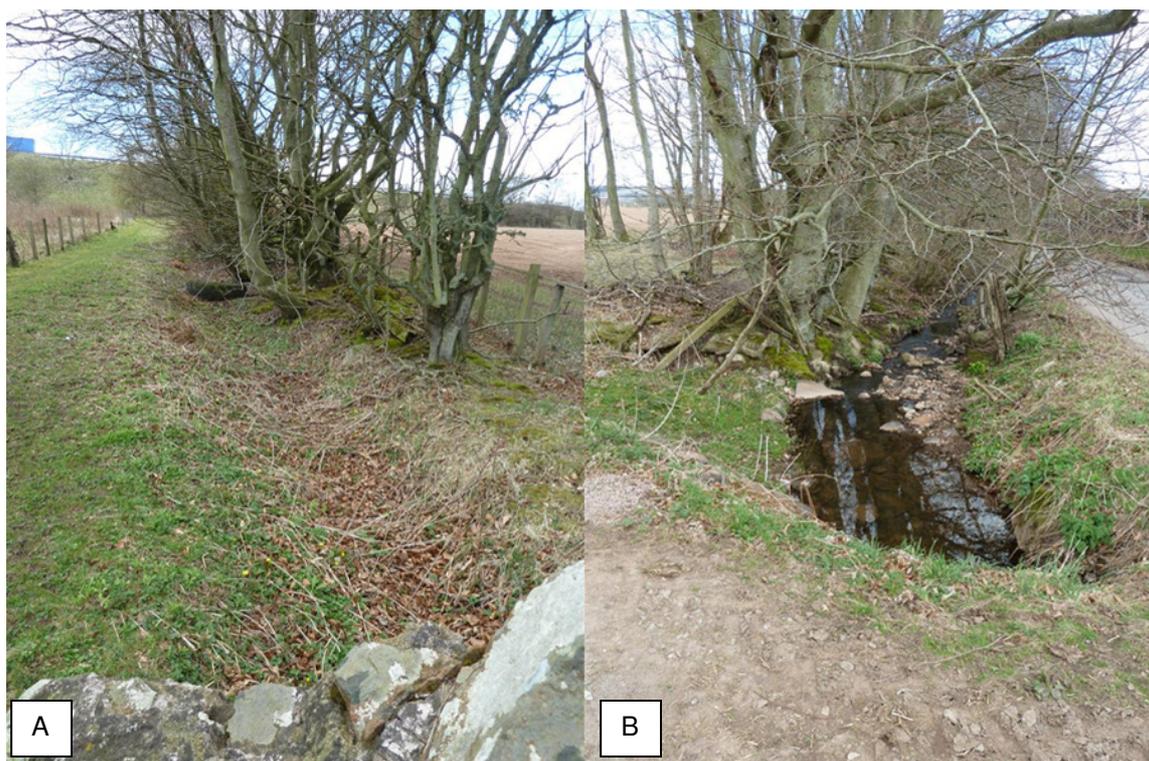
Figure 3-16: Unnamed tributary

OS mapping suggests that a small watercourse originates to the west of the A90 / A92 interchange and flows north east, joining the Carron Water downstream of the Toucks Burn confluence. Figure 3-16A is taken from Dunottar Church road and looking towards the A90, this flow pathway was dry at the time of the site visit. Further investigations into the pathway of this unnamed watercourse would be required. Figure 3-16B is then from the same location looking north east along the edge of Dunnottar Church road.
