Stonehaven December 2012 Flood Event Review

Final

April 2013

Aberdeenshire Council
Carlton House
Arduathie Road
Stonehaven AB39 2DP

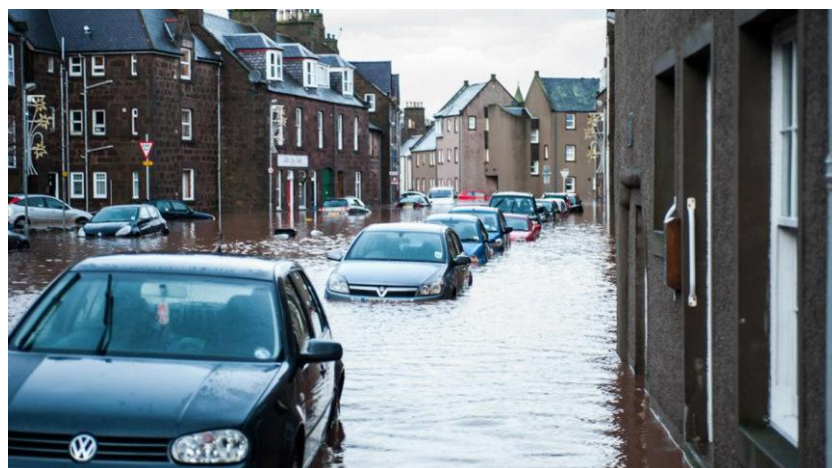
Figure 2-1: Flooding High Street²

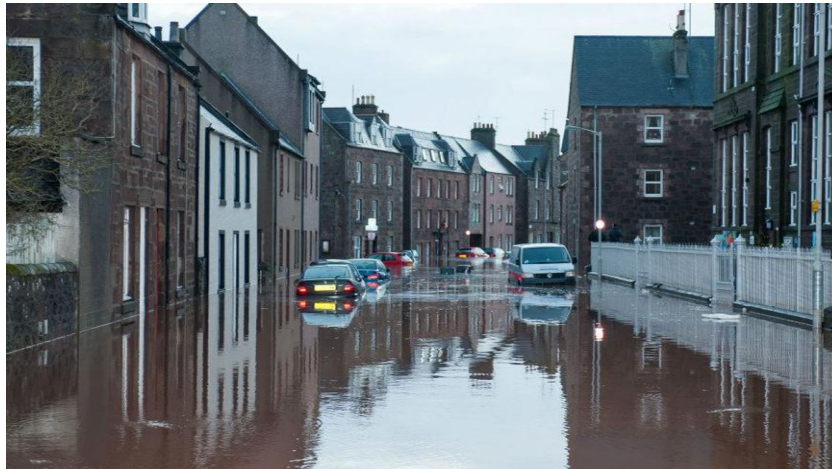
Figure 2-2: Flooding High Street³

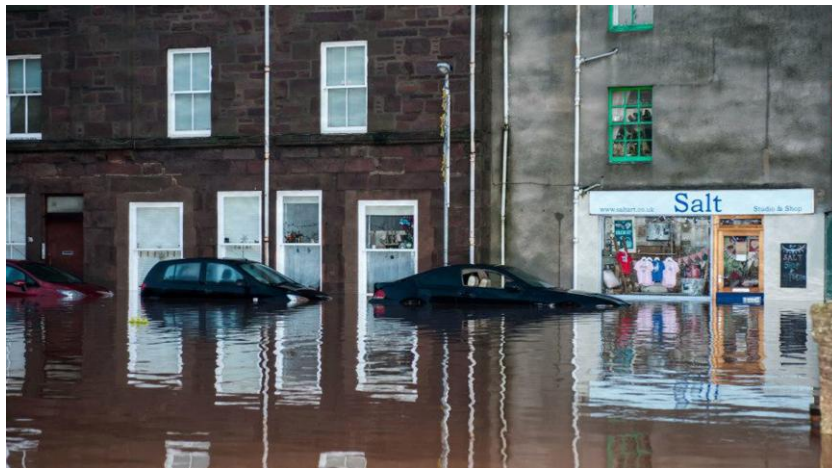
Figure 2-3: Flooding High Street⁴

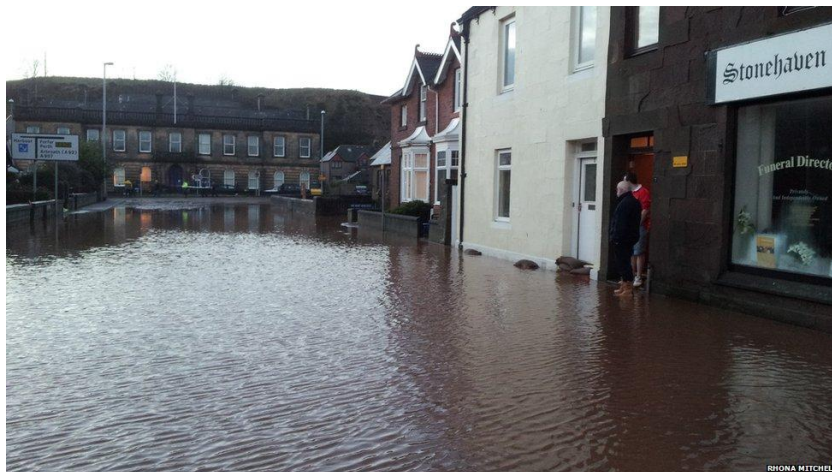
Figure 2-4: Flooding A957 Bridgefield⁵

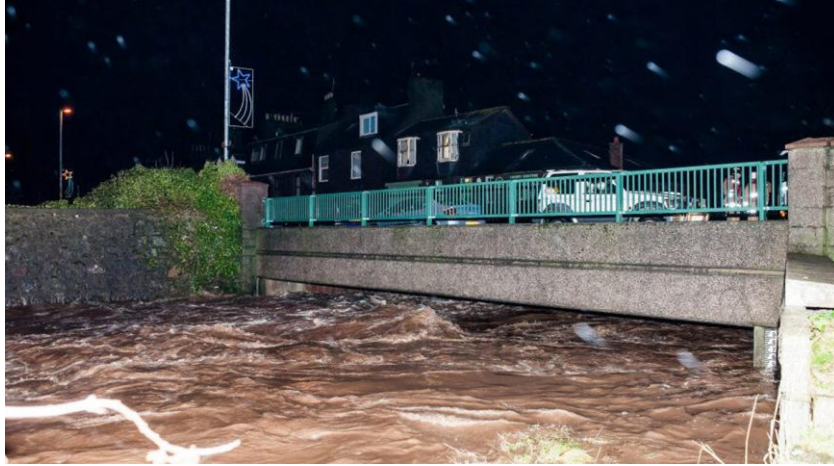
Figure 2-5: River Carron Looking at the Downstream Soffit of Bridgefield Bridge⁶

During the flood event, levels in the River Carron were close to soffits of both the White Bridge and Bridgefield Bridge. This can give a good indication of levels experienced during the event. Figure 5-2 demonstrates how the hydraulic model levels closely matched observed levels during the event. Photographed levels at the White Bridge appear higher than predicted. This is possibly due to turbulent waters in the reach producing a wave surge effect at the bridge. This would not be replicated by a hydraulic model though would be taken into account when calculating freeboard in the design of flood defences.

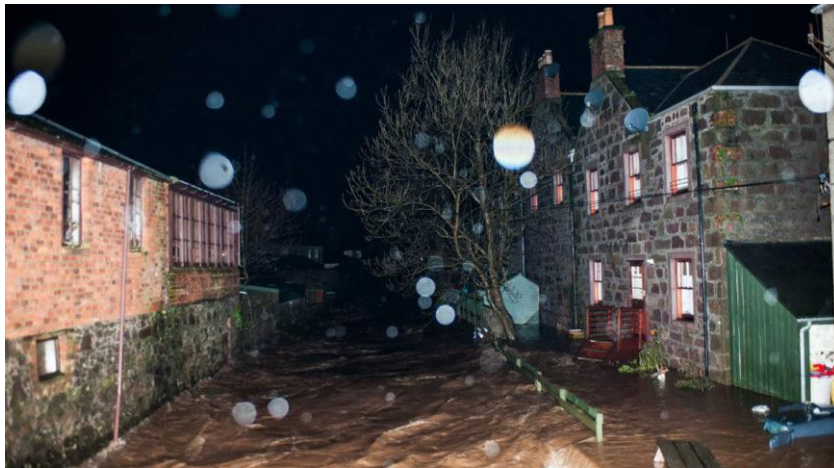
Figure 2-6: River Carron Looking Upstream from Bridgefield Bridge⁷

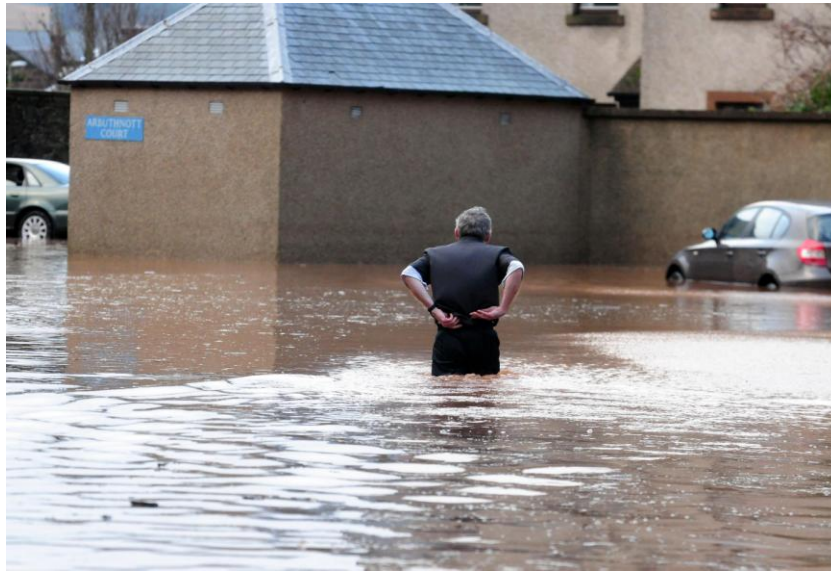
Figure 2-7: Flooding Arbuthnott Court⁸

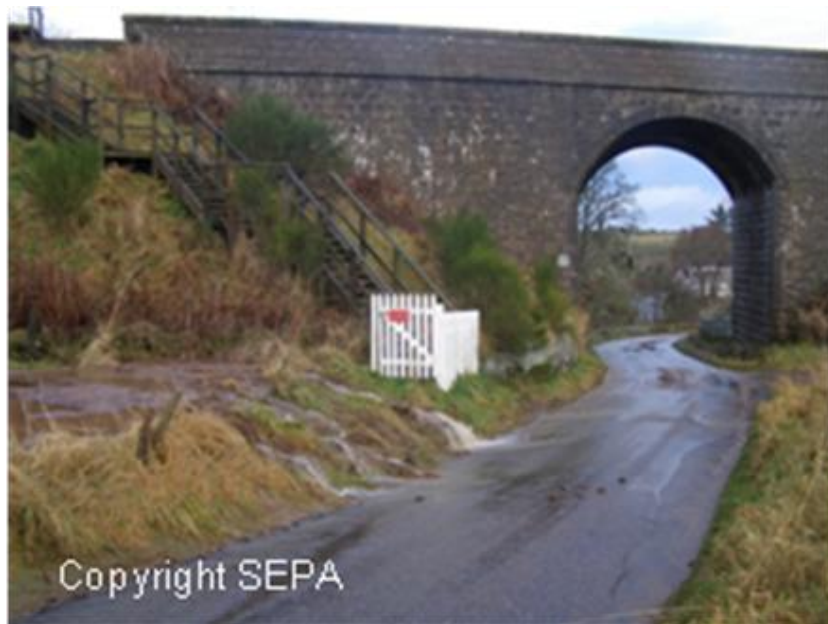
Figure 2-8: Water Flowing off fields upstream of SEPA's Fetteresso gauge

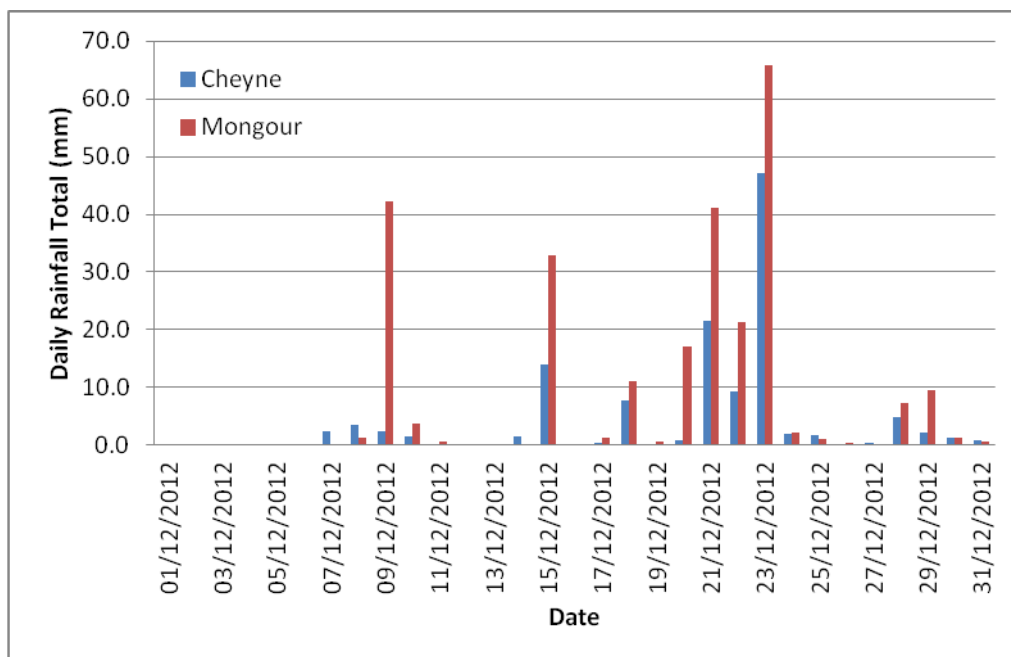
Daily rainfall totals (where a daily total is taken each day at 09:00 hrs) have also been extracted for the month of December 2012 for both rainfall gauges and can be seen in Figure 3- and Table 3-8.

Figure 3-5: Rainfall Data December 2012

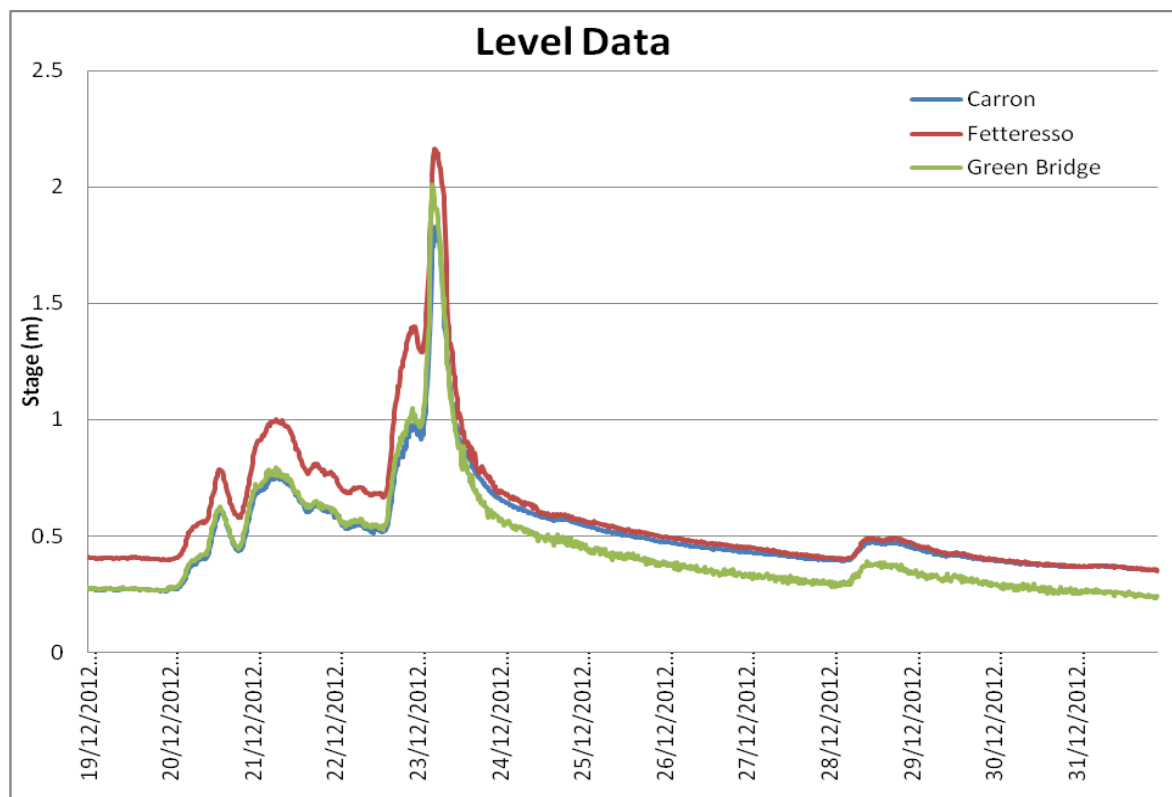
Figure 3- below shows the stage recorded at the Fetteresso, Carron and Green Bridge gauges. Water levels in the Carron Water started to rise on 20 December reaching their peak between 04:00hrs and 06:00hrs on 23 December. Between 16:00hrs on 22 December 2012 and the peak at the Carron gauge the water levels in the river rose by 1.23m. It can be seen from Figure 3-7 that the three gauges show peak water levels occurring within a short time period.

Figure 3-7: Level Data December 2012

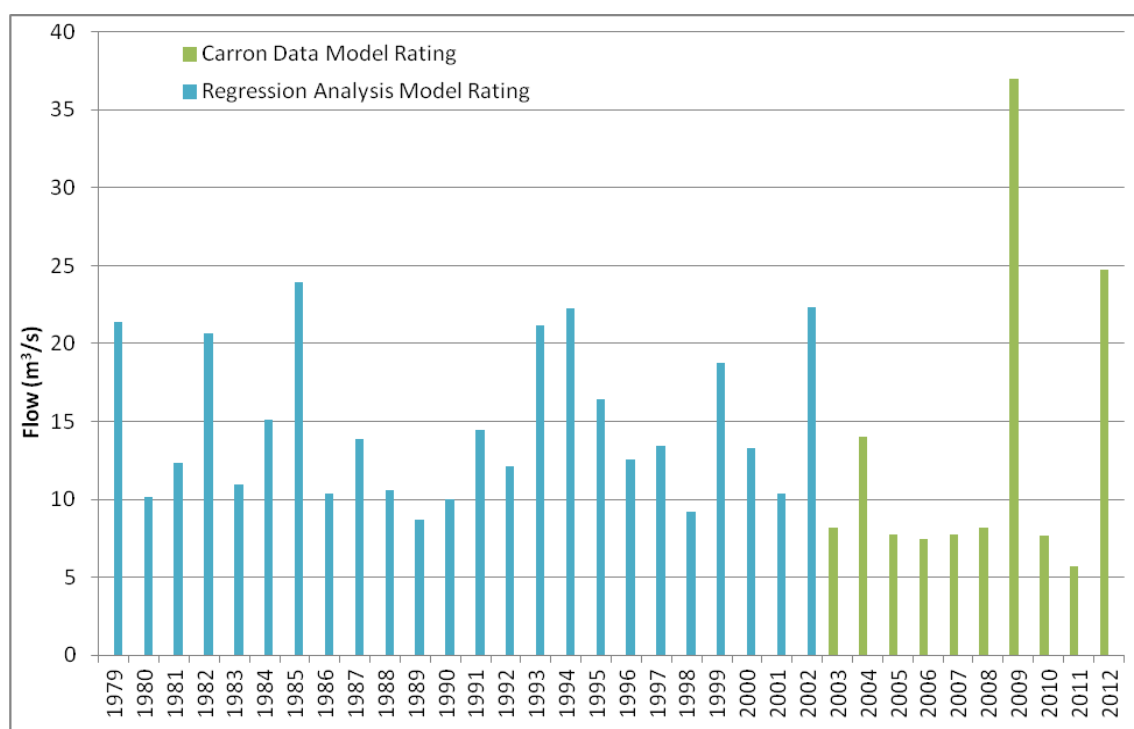
- POT data series using gauged data only for the Carron gauge recorded between 2003 to 2013:
 - i. Using the SEPA rating to convert level to flow.
 - ii. Using the Model rating to convert level to flow.
- AMAX series extended back to 1979 using regression analysis between the River Carron and the Bervie:
 - iii. Using the SEPA rating to convert level to flow.
 - iv. Using the Model rating to convert level to flow.

Figure 3-8: AMAX Series - Gauges data and Regression

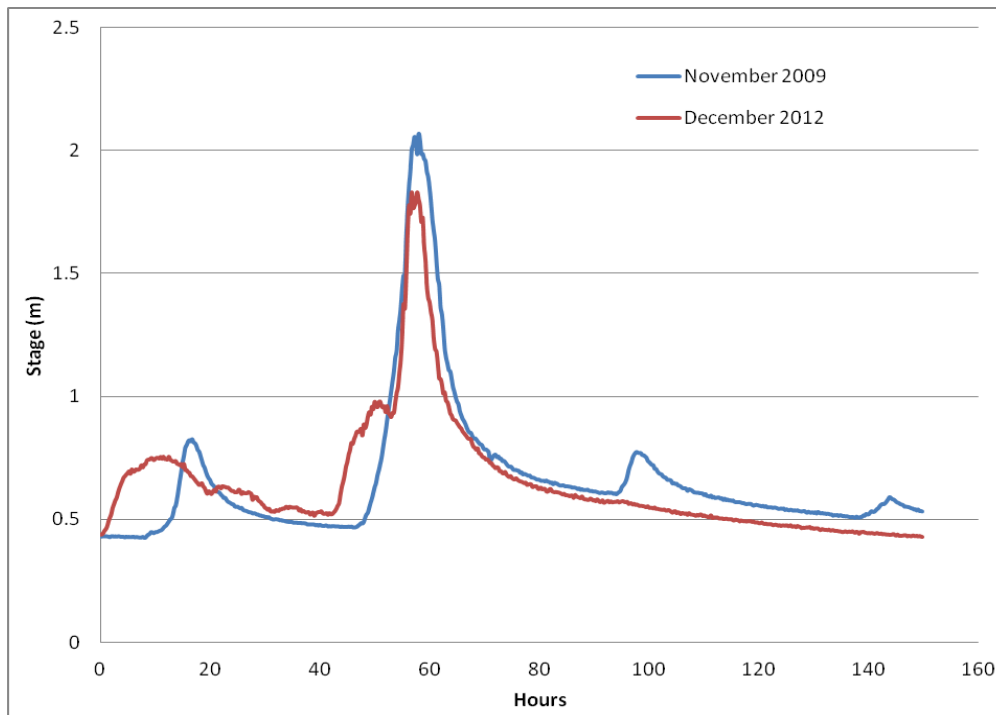
When plotting the levels versus time of the November 2009 and December 2012 events centred on the peak, it can be seen in Figure 3- that the rate of rise for both events was very similar. When considering the hydrographs of both events, although the 2009 event had a peak flow which was approximately 34% greater than that of the 2012 event, the difference in total volume was only about 11% (1157786m³ and 1023390m³).

Figure 3-9: November 2009 and December 2012 recorded stage

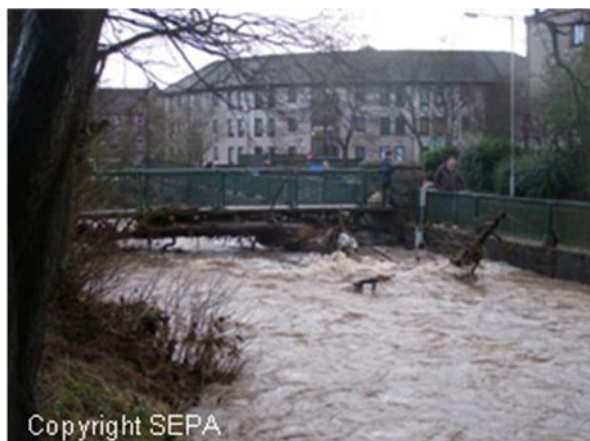
When considering the available data for the River Carron only for the November 2009 and December 2012 events it can be seen that the stage recorded at the SEPA Carron gauge was 0.23 m higher in November 2009 (Table 3-10). During both events it is noted that significant debris was caught on the Green Bridge (Figure 3-). Anecdotal evidence suggests that water levels were significantly higher in the Glaslaw Burn in December 2012.

Figure 3-10: Tree Trapped on Green Bridge December 2012

- Blockage at the Green Bridge.
- Higher flows in the Glaslaw Burn and overflow into the High Street.
- Runoff and overland flow from Bervie Braes.
- Flows largely retained within bank on Carron Terrace on the left bank by demountable defences.

The 2012 flood was of a smaller magnitude than the 2009 flood on the River Carron. However the blockage at the Green Bridge is likely to have elevated water levels sufficiently such that significant flood waters left the Carron upstream of the Green Bridge.

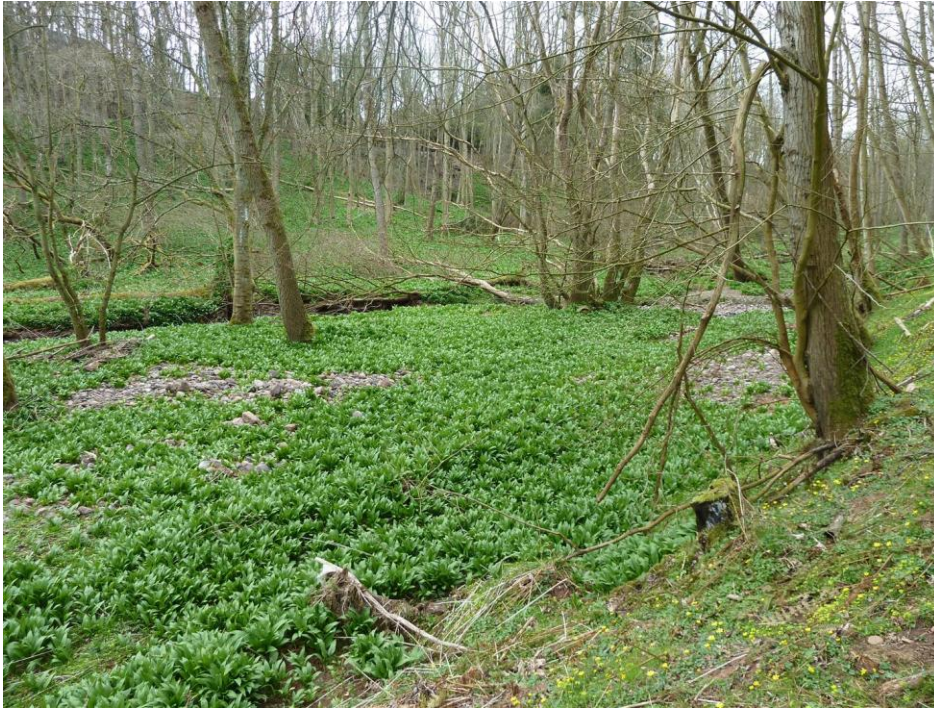
A site walkover assessment of the burn following the flood event showed evidence of high flows in the burn as shown in Figures 3-12 and 3-13. Figure 3-11 shows the locations of the sections of the Glaslaw Burn used in the hydraulic model.

Figure 3-12: Large gravel deposits in active floodplain of the Glaslaw Burn. (section GLA_653)

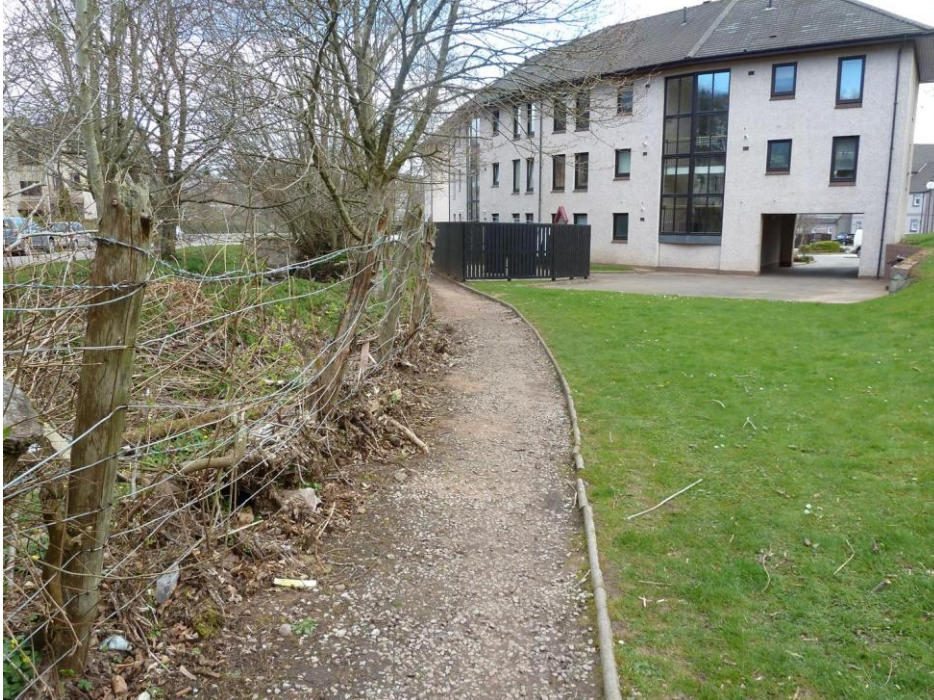
Figure 3-13 Wrack marks on fencing upstream of Woodview Court. (section GLA_179)

Reports of the flooding from the Glaslaw Burn indicated that water left the channel upstream of Carron Gardens (approximately at section GLA_222) on the left bank and flowed through Carron Gardens. Water also left the channel upstream of the culvert between sections GLA_089 and GLA_070 and flowed into Woodview Court. Additionally water left the burn on both banks downstream of section GLA_070. Table 3-12 indicates the required flow to replicate these observations.

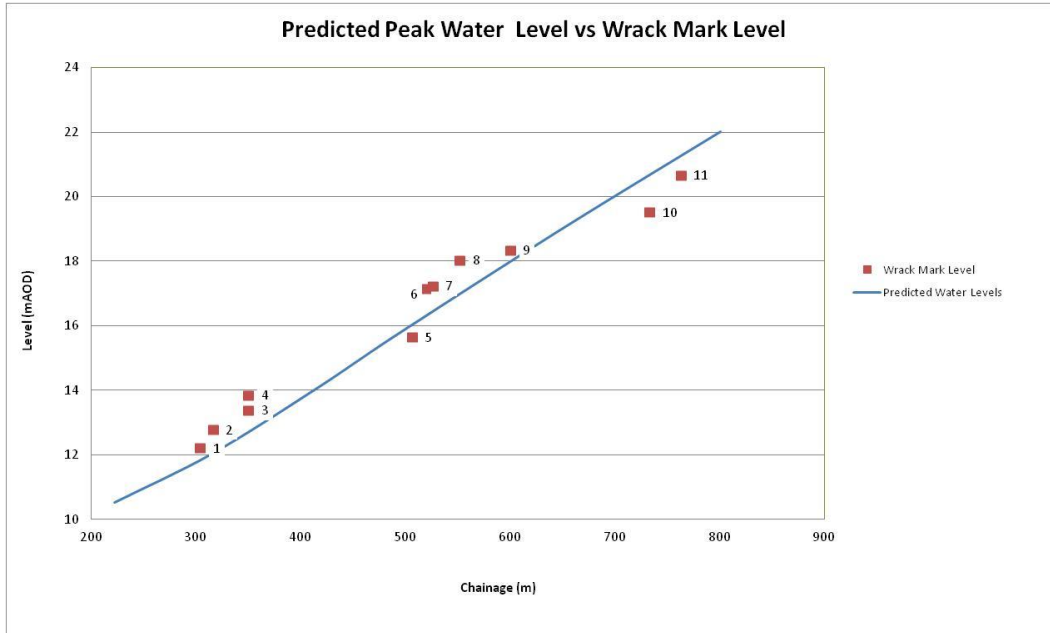
Figure 5-4: Predicted Water Levels vs. Wrack Mark Level

It can be seen from Figure 5-4 that a fairly good correlation has been achieved although the wrack levels are higher than that of the predicted peak water levels. It is noted that the surveyed wrack marks were located on larger debris within the Glaslaw Burn as shown in Figure 5-5. Some of the marks may be associated with superelevation at bends or as they pile up against obstructions. The levels taken could indicate extreme flows on the Glaslaw Burn or that the wrack marks are higher than the flood water.

There is still a degree of uncertainty pertaining to the December 2012 flood event on the Glaslaw Burn due to the lack of recorded data. However, the observations made during the flood event have allowed an estimate of the flow to be arrived at by deriving the required flow to meet these observations, namely the burn overflowing its banks at Carron Gardens and Woodview Court. It is considered that the flow in the burn would have been approximately 6-7m³/s which would be in the order of a 75 year return period.

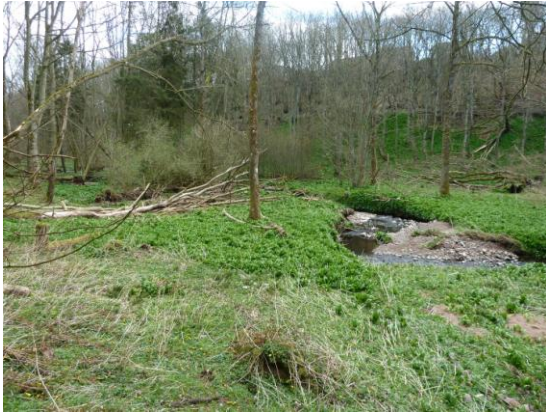
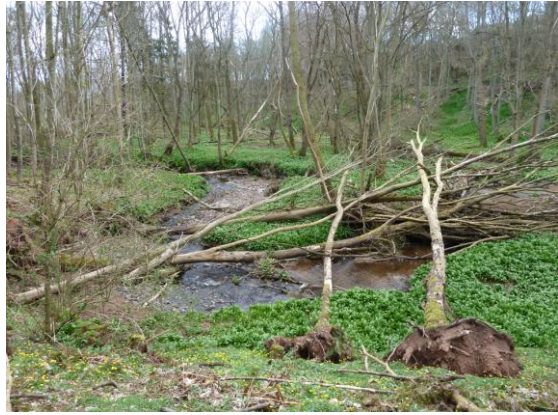
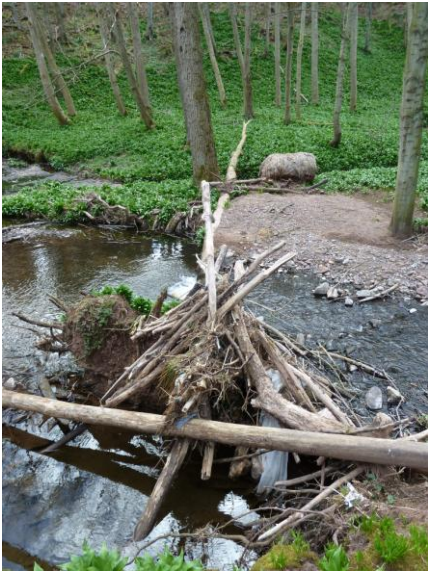
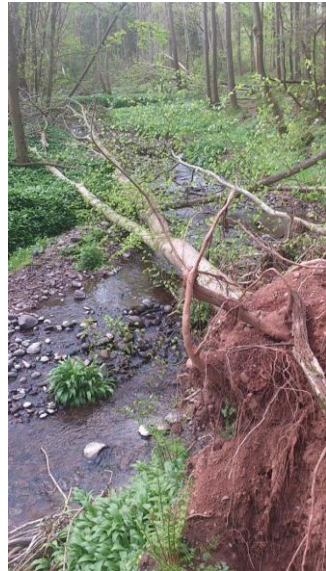
Figure 5-5: examples of debris in Glaslaw Burn

Recommendations include the gathering of more specific flood level data for the December 2012 event, the installation of a level logger on the Glaslaw Burn and channel maintenance.

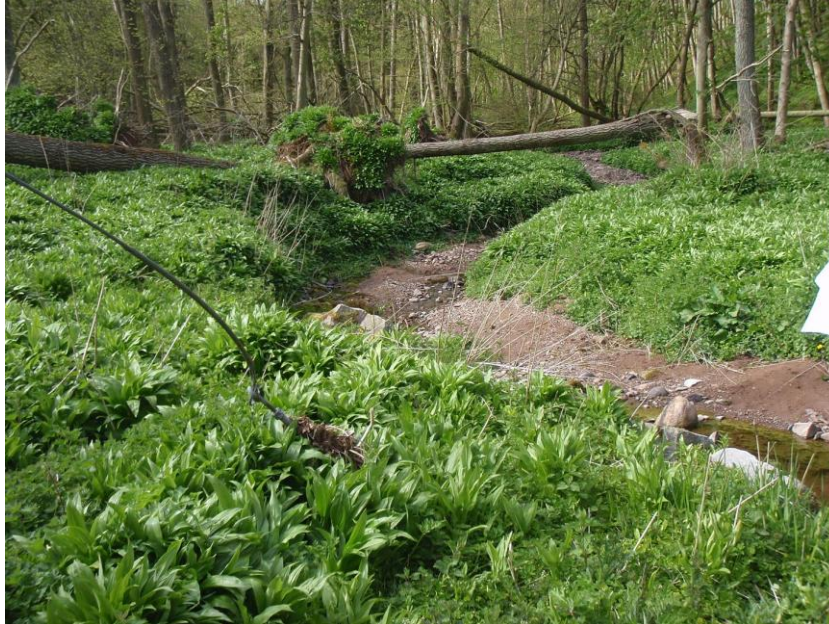
Wrack Mark One: Deposit on cable

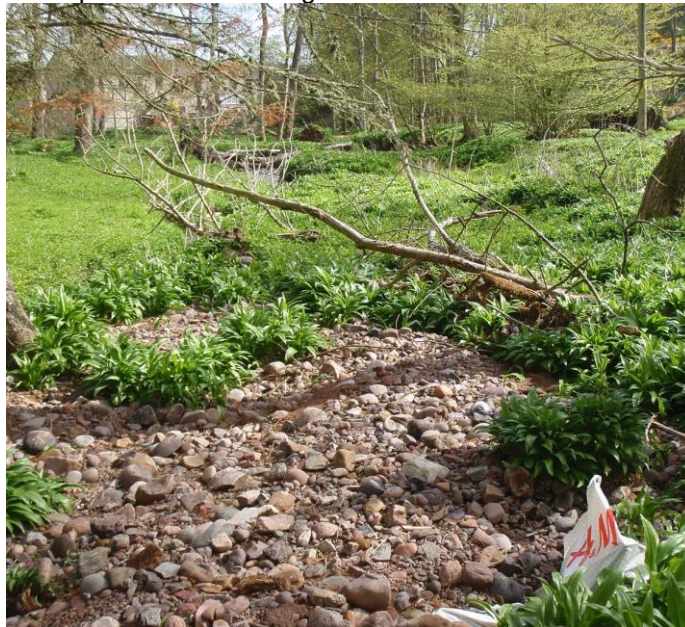
Wrack Mark Two: Gravel deposits on elevated ground between two channels

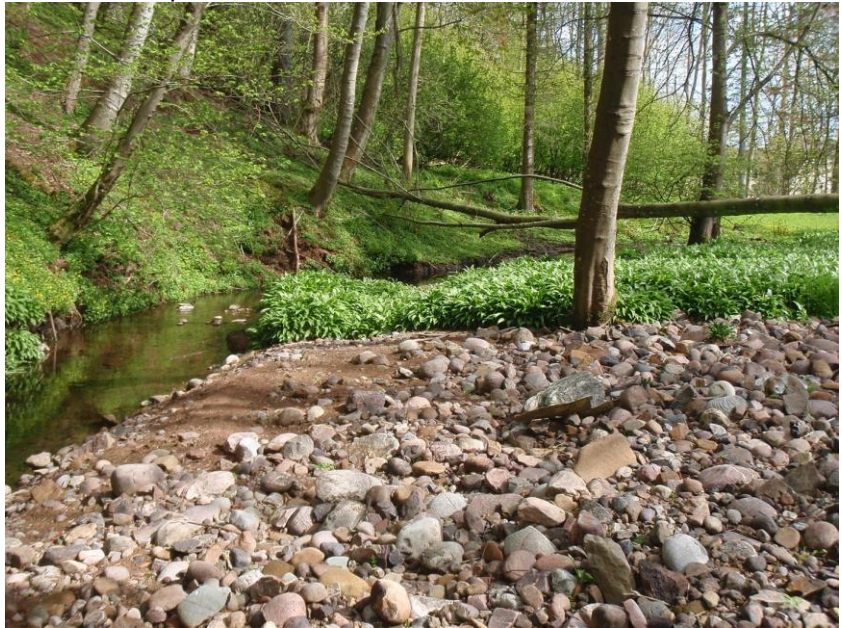
Wrack Mark Three: Gravel deposits at start of bifurcation of channel

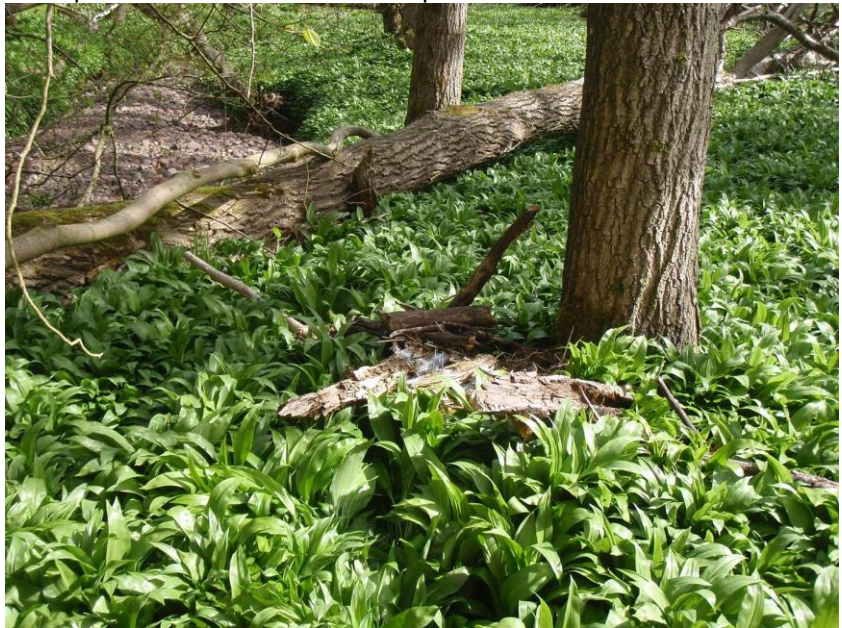
Wrack Mark Four: Deposits at base of tree in flood plain

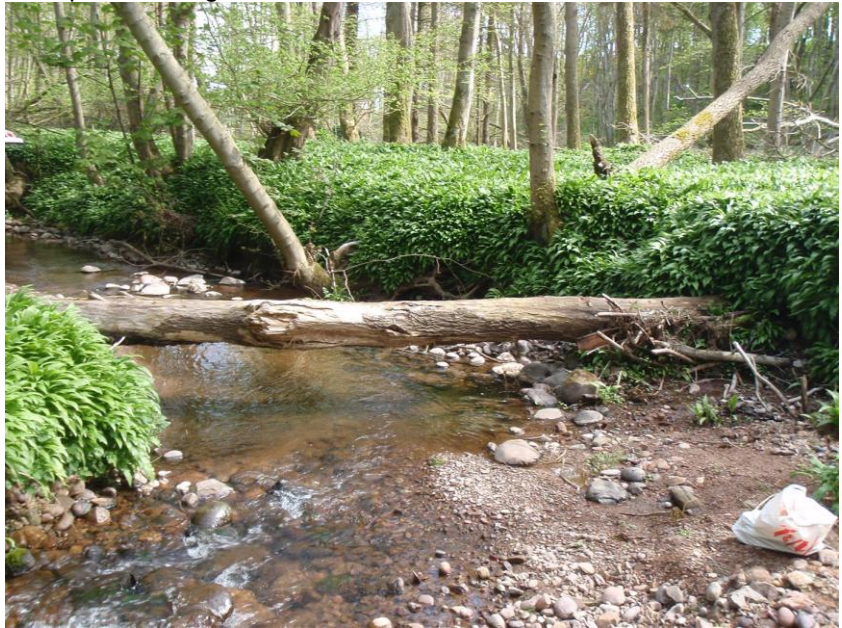
Wrack Mark Five: Deposits on log across channel

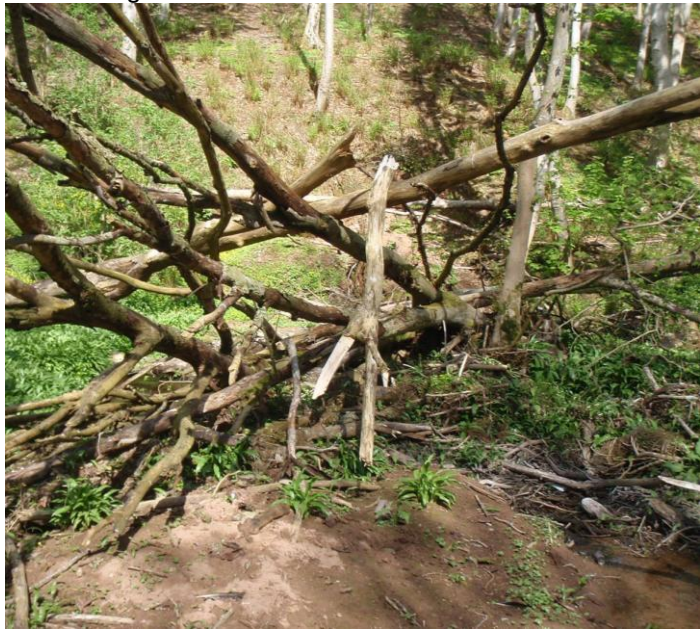
Wrack Mark Six: deposits on large wood debris in channel

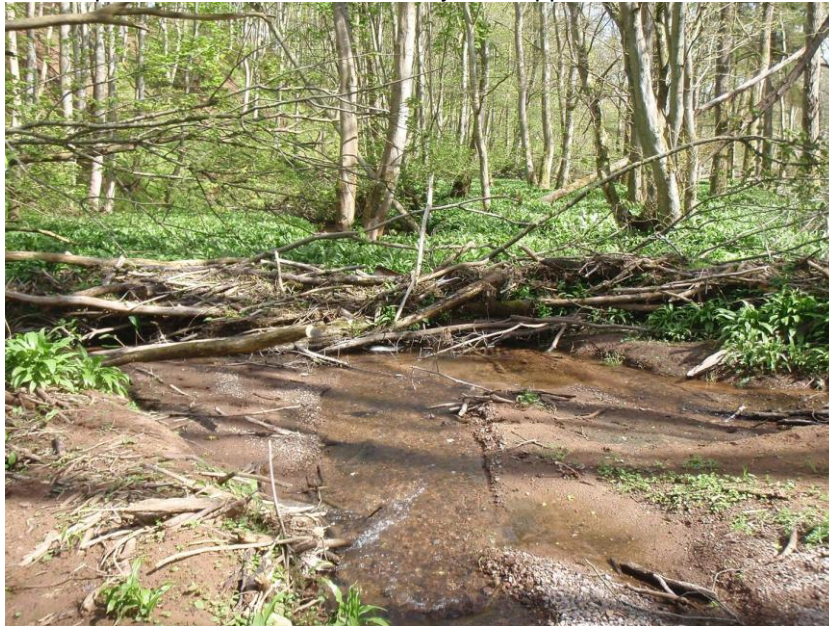
Wrack Mark Seven: Deposits on banks that was likely overtopped

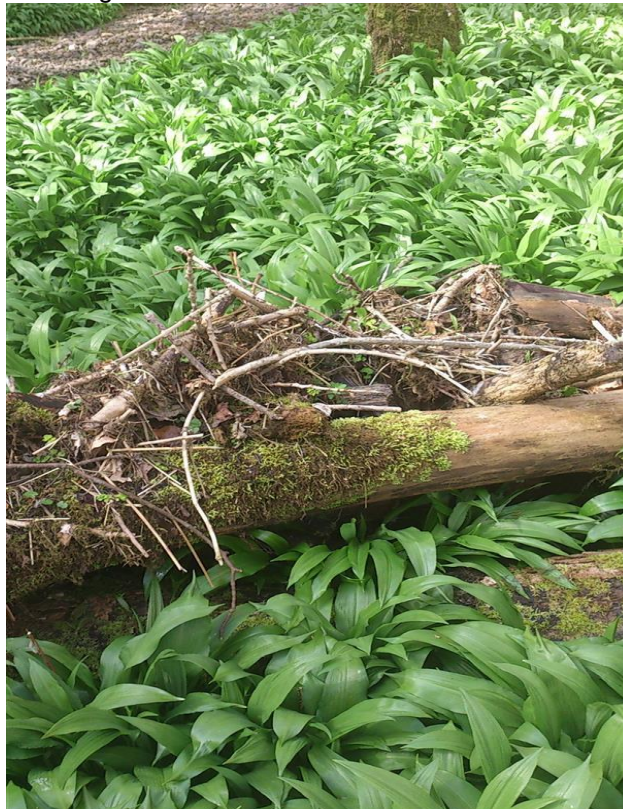
Wrack Mark Eight: Deposit on log on left bank of channel

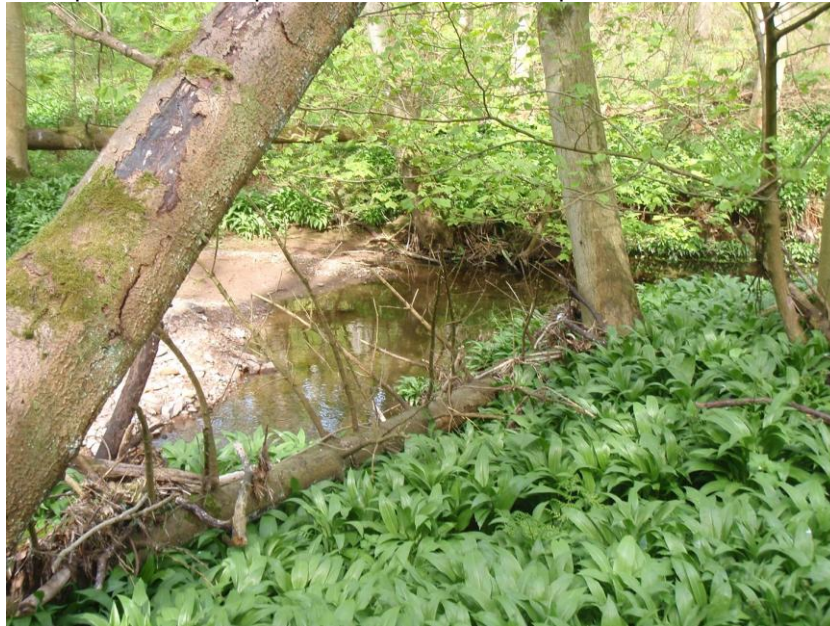
Wrack Mark Nine: Deposits on flood plain on left bank of flood plain

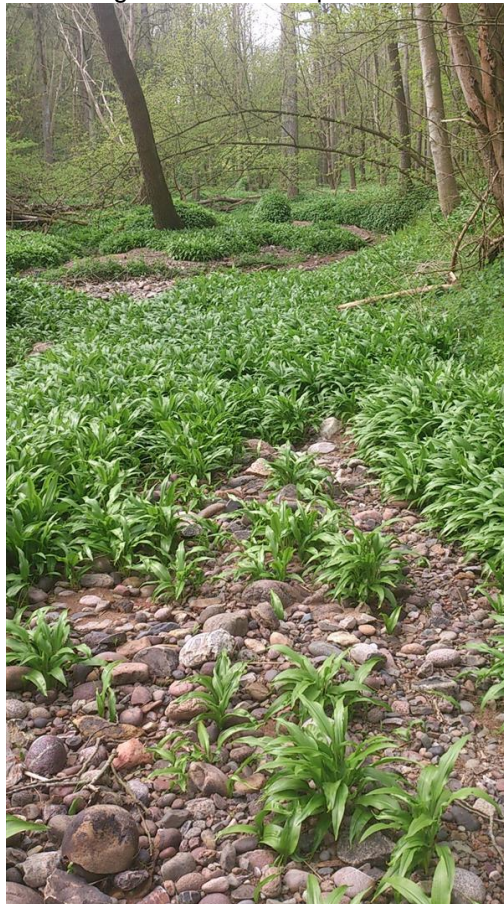
Wrack Mark Ten: Gravel deposits on right bank in flood plain

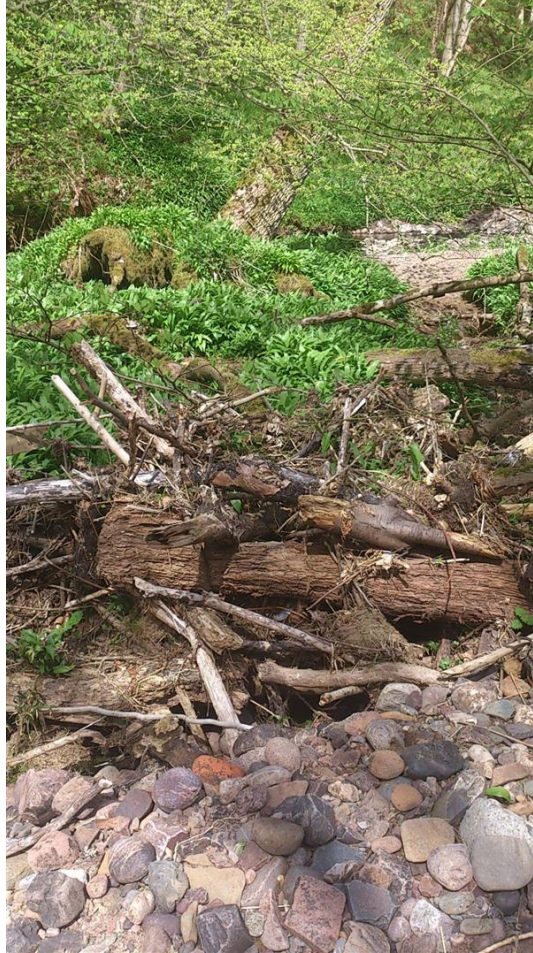
Wrack Mark Eleven: Deposits on wooded debris on right bank of channel
