Reference & Chainage	LS15 0.705-0.736	Location	OS NGR 386977,785653
Date of Inspection	7 April 2010	Inspector(s)	Stephen Farrar
Nature of Inspection	Visual	Nature of Assets	Wall
Model cross section showing peak 0.5% AP (200 year) event water level

Aberdeenshire Council
Stonehaven River Carron Flood Alleviation Studies
Location Plan - CH 700 - CH 1600

Aberdeenshire Council
Stonehaven River Carron Flood Alleviation Studies
Location Plan - CH 2500 - CH 3300
Structures Inspection

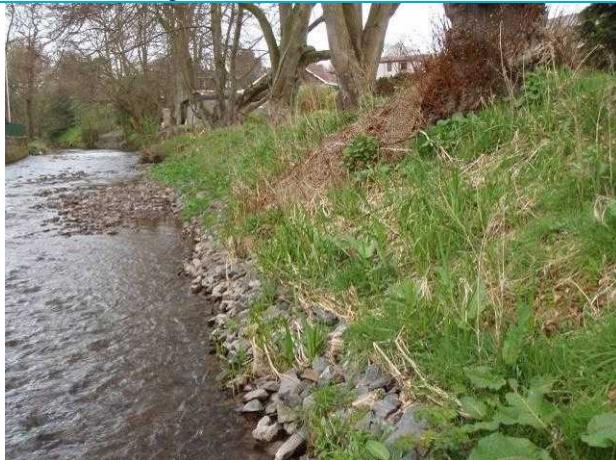
Photograph 5: Section of recently installed earth embankment, raised to prevent local flooding.
Looks well vegetated and stable.

Description	Earth embankment, with stone protection at base, and sandbags around garage.	
Anticipated Ground Conditions	Sand & Gravels.	
Potential Ground Investigation	Type	In situ SPT's, Soil grading
	Access	Good at top of embankment, although services likely to be present and partial road closure req.
Structural comments	Embankment appeared reasonably intact, although because it has been recently constructed it is not clear how it would perform under flood flows.	
Design considerations	Flood defence wall may be built along side of road on piles to avoid damage to tree roots.	
General condition	Good	
Remedial action required	None

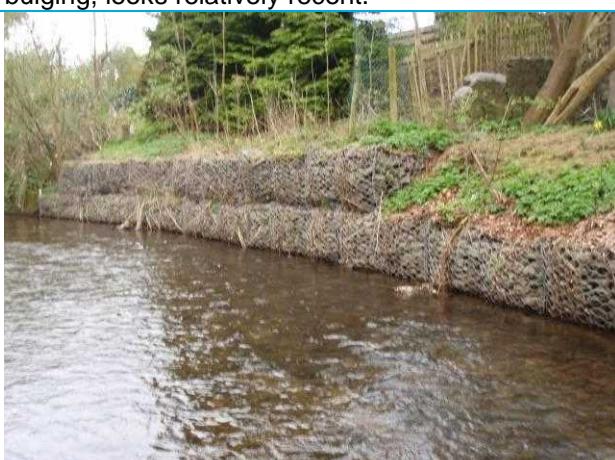
Photograph 1: Gabion wall, showing some signs of bulging, looks relatively recent.

Description	Gabion Wall	
Anticipated Ground Conditions	Sand & Gravels.	
Potential Ground Investigation	Type	In situ SPT's, Soil grading
	Access	Access along bank, limited space for investigation.
Structural comments	Some signs of bulging possibly due to gabions being filled with small rounded or sub angular stone. No signs of settlement.	
Design considerations		
General condition	Good.	
Remedial action required	None

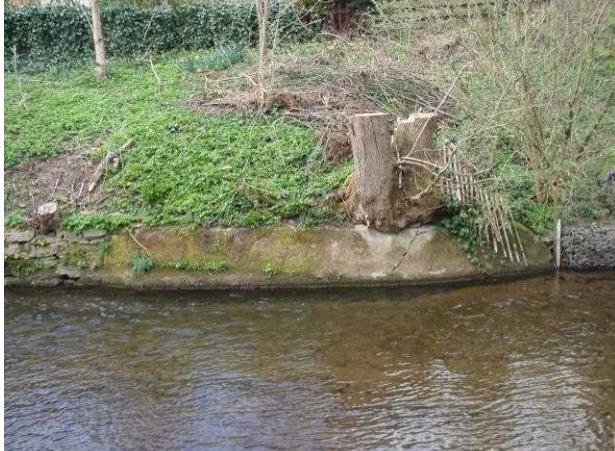
Photograph 1: View of rendered wall showing signs of cracking, and vegetation growth.

Description	Drystone wall with partially rendered face.	
Anticipated Ground Conditions	Sand & Gravels.	
Potential Ground Investigation	Type	In situ SPT's, Soil grading
	Access	Access along bank, ground sloping, quite steeply. Limited access for vehicles.
Structural comments	Some signs of movement. Appears reasonably stable, although on inside of bend so not subject to high velocities and erosion.	
Design considerations		
General condition	Fair	
Remedial action required	Some consolidation of wall required, using traditional drystone walling techniques.

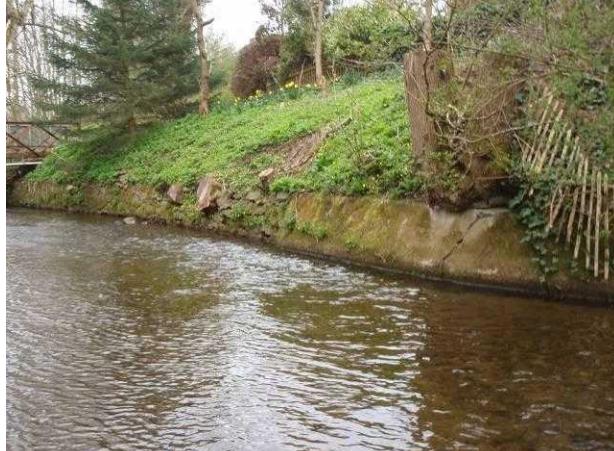
Photograph 2: View of wall up to bridge. Note tree growth.

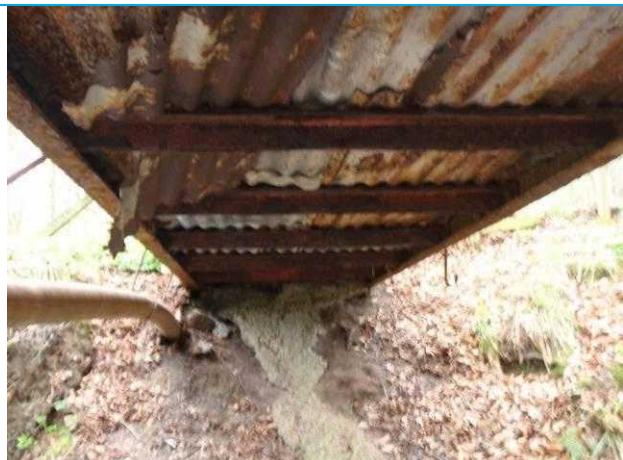
Photograph 5: View below deck towards RHB

Description	Steel truss bridge supporting concrete deck. Abutments not visible likely mass concrete or stonework.	
Anticipated Ground Conditions	Sand & Gravels.	
Potential Ground Investigation	Type	In situ SPT's, Soil grading
	Access	
Structural comments	Steel extensively corroded. Steel nuts and bolts showing signs of severe corrosion.	
Design considerations	The bridge may be acting as choke point. It should be possible to free the ends and jack it up. Abutments may need rebuilding.	
General condition	Fair	
Remedial action required	Loose sheeting and ducts to be removed. Bridge requires repainting, and ideally a new deck.

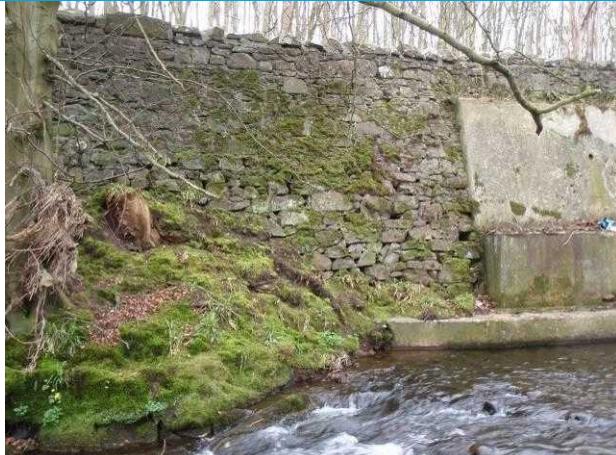
Photograph 1: Downstream end of wall, showing area of loose stonework.

Description	Drystone retaining wall, reinforced with concrete wall	
Anticipated Ground Conditions	Fill over Sand & Gravels.	
Potential Ground Investigation	Type	In situ SPT's, Soil grading
	Access	Good, although services likely to be present and partial road closure required.
Structural comments	Some loose stonework in drystone wall, otherwise wall looks stable and intact.	
Design considerations		
General condition	Fair	
Remedial action required	Some consolidation of wall required, using traditional drystone walling techniques.

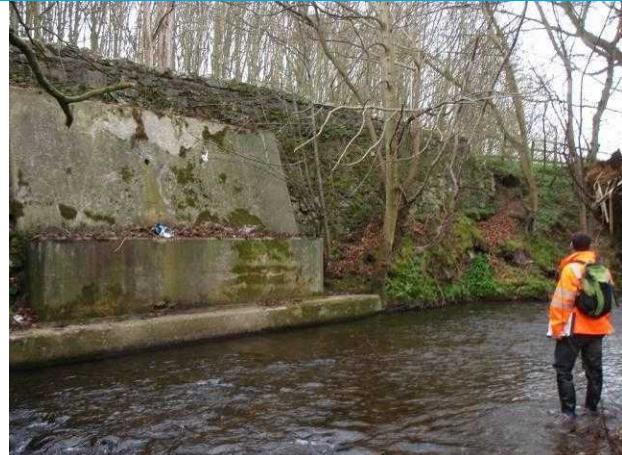
Photograph 2: Middle and upstream end of wall, showing area of loose stonework.

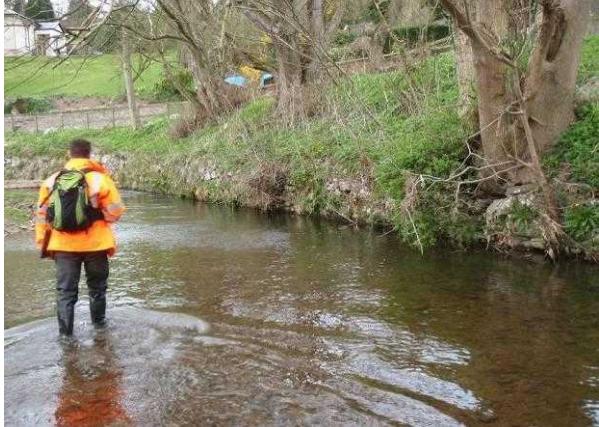
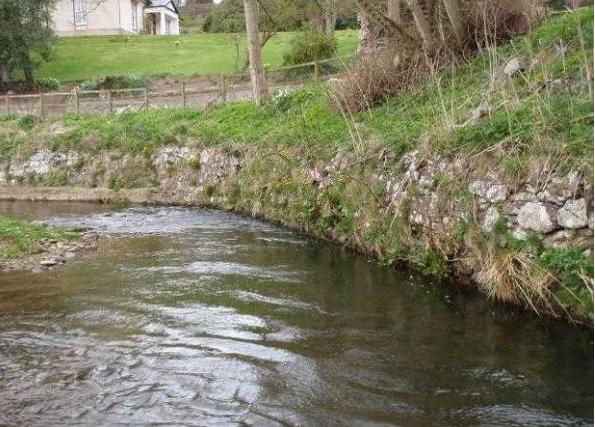
<p>Photograph 5: Drystone wall at start of bend.</p>	<p>Photograph 6: Drystone wall at start of bend (cont.).</p>

Description	Drystone wall, with concrete cill added at base to prevent corrosion	
Anticipated Ground Conditions	Sand & Gravels.	
Potential Ground Investigation	Type	In situ SPT's, Soil grading
	Access	Access through private land/gardens, although many areas difficult some areas have reasonably good access.
Structural comments	Although wall has large areas with loose stones, and some areas are showing signs of bulging, this is mainly due to vegetation growth. The majority of the wall is intact and no areas have collapsed. It is unclear how deep the concrete sill extends.	
Design considerations		
General condition	Fair, although this could deteriorate quickly to poor if no remedial action undertaken.	
Remedial action required	Wall may be consolidated and rebuilt in areas using traditional drystone walling techniques.

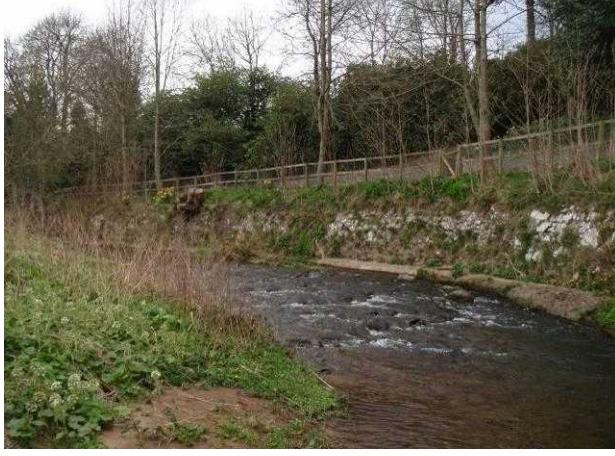
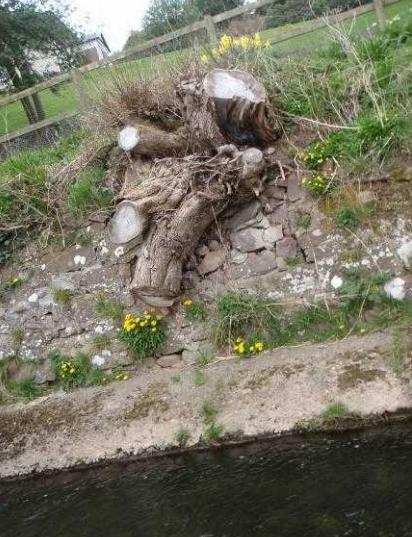
<p>Photograph 7: Drystone wall, note concrete sill.</p>	<p>Photograph 8: Tree growth from wall.</p>

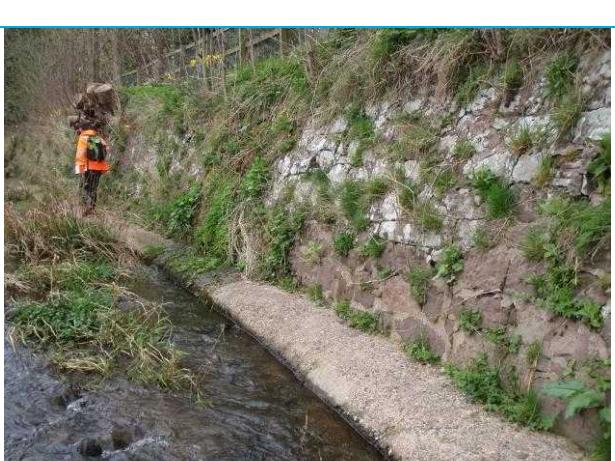
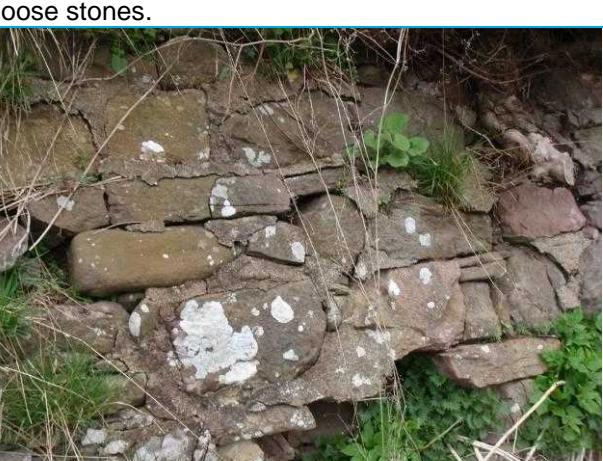
<p>Photograph 9: View along drystone wall.</p>	<p>Photograph 10: Close up. Base of wall has been pointed in places with cement based pointing, note loose stones.</p>

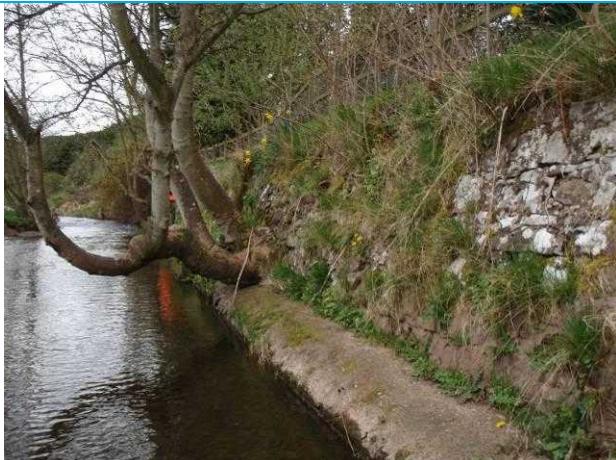
Photograph 11: Tree growth from base of wall (tree has been ring barked).

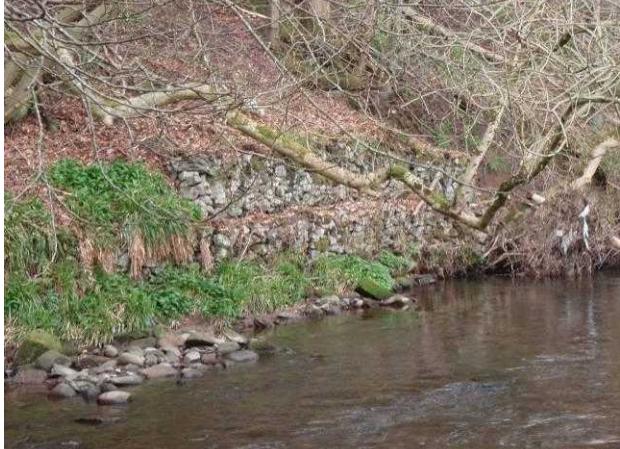
Photograph 1: View of gabion wall, which is well vegetated.

Description	Gabion wall placed to prevent landslip extending.
Anticipated Ground Conditions	Sand & Gravels.
Potential Ground Investigation	Type In situ SPT's, Soil grading Access Steep slope, difficult access
Structural comments	Gabion wall looks stable, and well vegetated.
Design considerations	
General condition	Good
Remedial action required	None at present

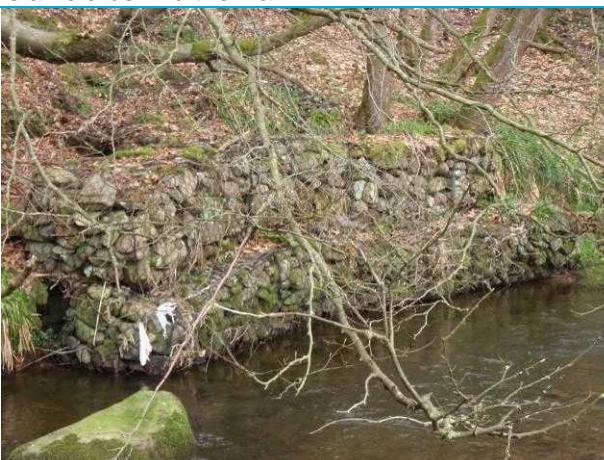
Photograph 1: View of gabion wall, looks like there is a void behind the wall.

Description	Gabion wall placed to prevent landslip extending.	
Anticipated Ground Conditions	Sand & Gravels.	
Potential Ground Investigation	Type	In situ SPT's, Soil grading
	Access	Access through walled garden, possibly accessible for terrier rig.
Structural comments	Wall shows signs of settlement on downstream end. A void is also visible behind the wall at this end. This is likely to be due to erosion of the soil behind and below the gabions at this end.	
Design considerations		
General condition	Fair	
Remedial action required	Erosion protection required, at base of Gabion wall.

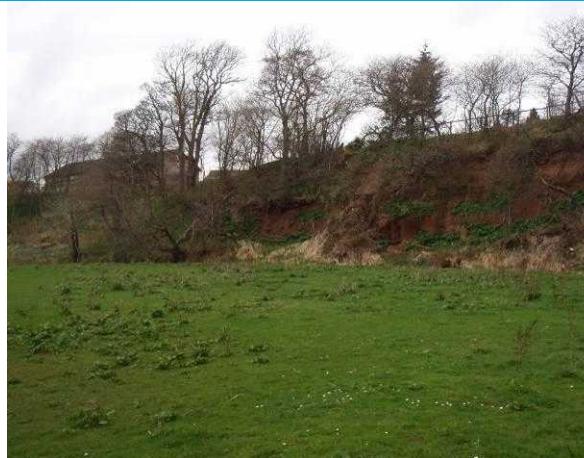
Photograph 1: View of steep bank on outside of bank showing extensive signs of instability.

Description	Earth Bank	
Anticipated Ground Conditions	Sand & Gravels.	
Potential Ground Investigation	Type	In situ SPT's, Soil grading
	Access	Access through private land/gardens likely to be good in places.
Structural comments	Bank shows widespread evidence of instability primarily due to erosion at toe. If left erosion might eventually endanger properties at top of embankment.	
Design considerations		
General condition	Slope natural and unreinforced. Condition acceptable if rate of erosion acceptable.	
Remedial action required	None at present.

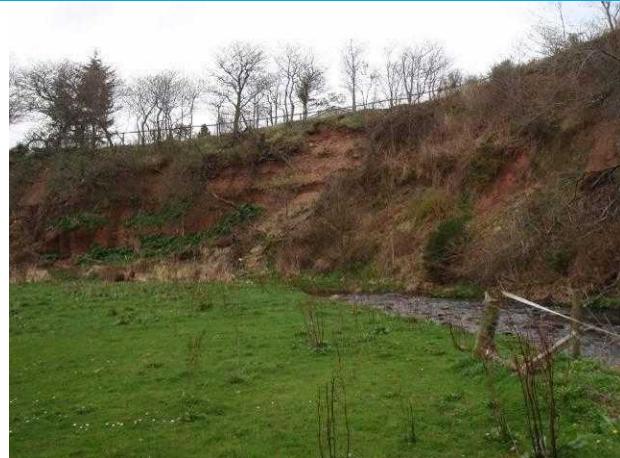
Photograph 2: View of steep bank on outside of bank (cont.).

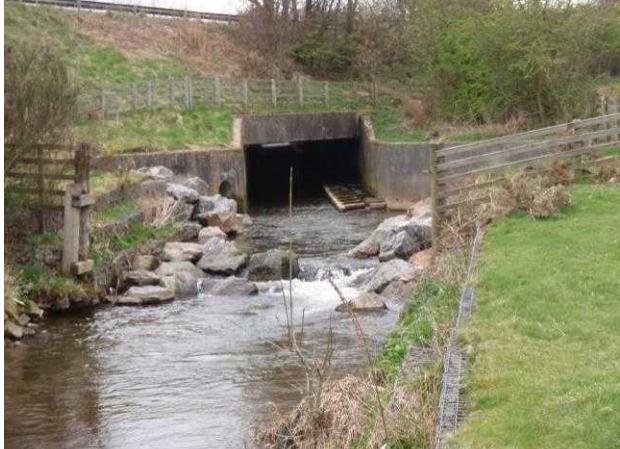
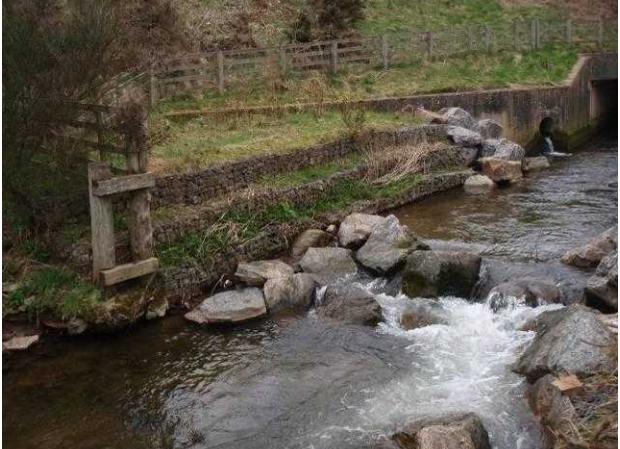
Reference & Chainage	B8 2.555-2.640	Location	OS NGR 385653,785536
Date of Inspection	7 April 2010	Inspector(s)	Stephen Farrar
Nature of Inspection	Visual	Nature of Assets	Culvert
Model cross section showing peak 0.5% AP (200 year) event water level			
Photograph 1: Exit to culvert.	Photograph 2: Gabion Wall on RHB below exit to culvert, note placement of stones in front of gabions.

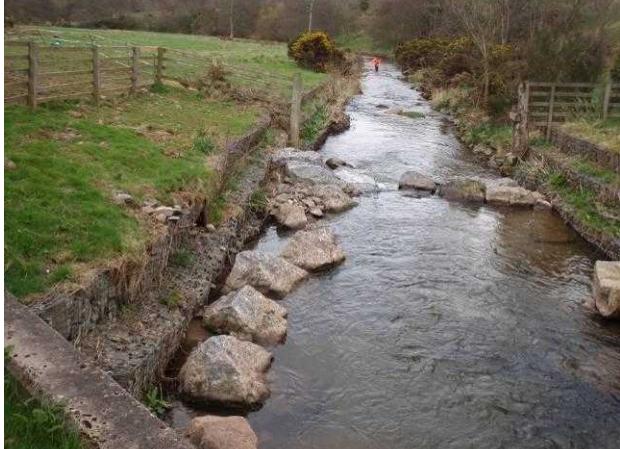
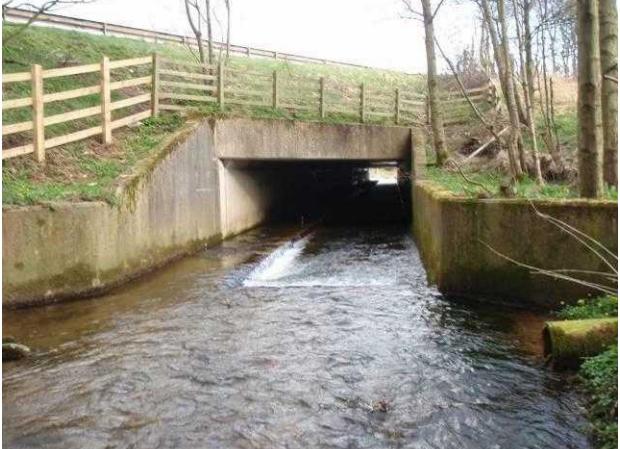
Photograph 3: Gabion Wall on RHB below exit to culvert, wall looks uneven. Note placement of stones in front of wall.	Photograph 4: View of entrance to culvert.

Description	Reinforced concrete 'box' culvert with fish ladder.	
Anticipated Ground Conditions	Sand & Gravels.	
Potential Ground Investigation	Type	In situ SPT's, Soil grading
	Access	Access, likely to be difficult, although records should exist for construction of culvert.
Structural comments	<p>Level of flood debris would indicate that culvert has been running full. Condition of culvert itself is good, although velocity of water is high at exit leading to erosion of river bed below gabions. Some rock armouring has been placed to prevent this.</p>	
Design considerations		
General condition	Good	
Remedial action required	None, although this should be reviewed at regular intervals.

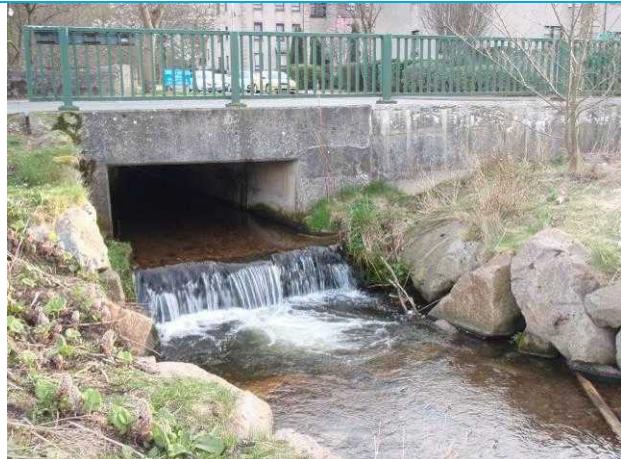
Photograph 1: View of exit to culvert.

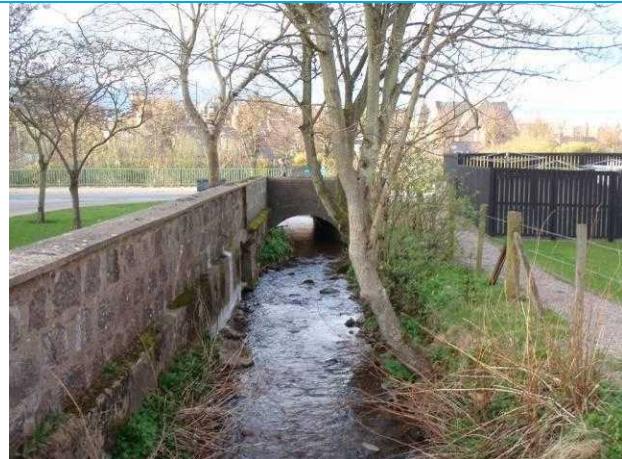
Photograph 1: View of showing entrance to culvert.

Description	Concrete arched culvert, with reinforced concrete spandrel wall on exit.	
Anticipated Ground Conditions	Sand & Gravels.	
Potential Ground Investigation	Type	In situ SPT's, Soil grading
	Access	Good
Structural comments	No obvious signs of movement in abutments or arch.	
Design considerations		
General condition	Good	
Remedial action required	None

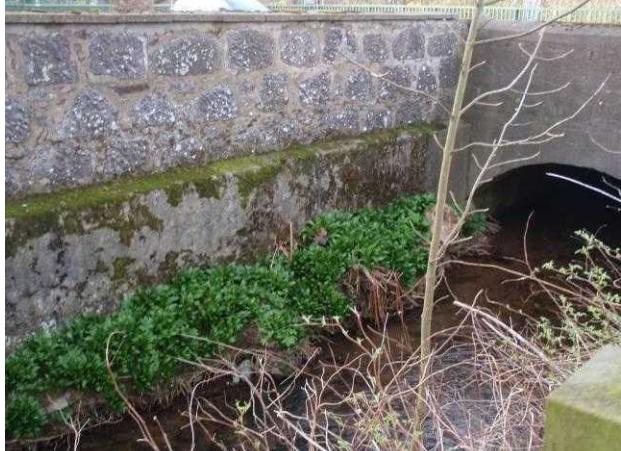
Photograph 1: View of wall.

Description	Stone wall on concrete base.	
Anticipated Ground Conditions	Sand & Gravels.	
Potential Ground Investigation	Type	In situ SPT's, Soil grading
	Access	Good
Structural comments	No obvious signs of movement. It is unclear how far the footings extend. Some growth of vegetation.	
Design considerations		
General condition	Good	
Remedial action required	None

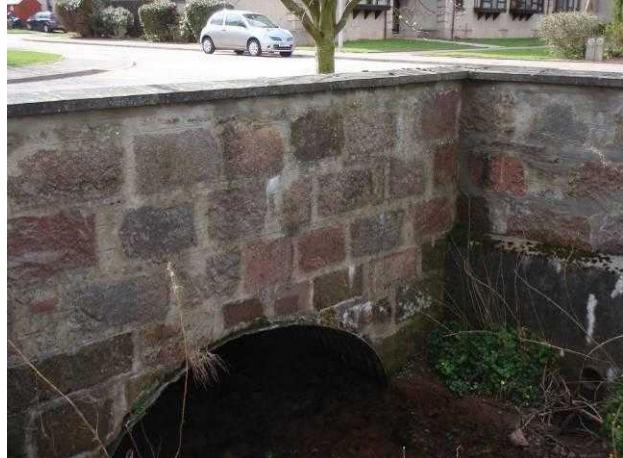
Photograph 1: Entrance to culvert.

Description	Concrete arch culvert with stonework spandrel walls.	
Anticipated Ground Conditions	Sand & Gravels.	
Potential Ground Investigation	Type	In situ SPT's, Soil grading
	Access	Good
Structural comments	No obvious signs of movement	
Design considerations		
General condition	Good	
Remedial action required	None

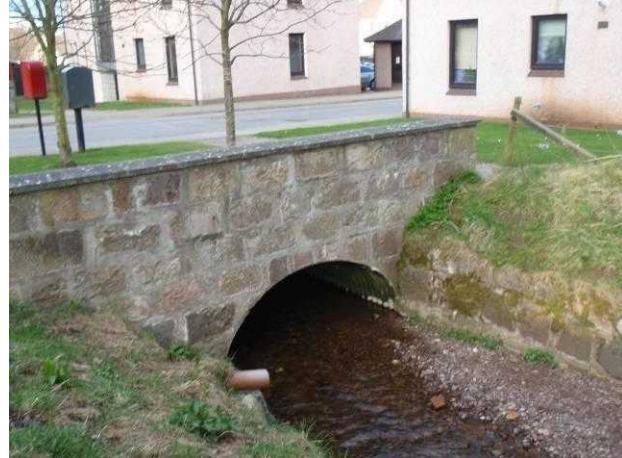
Photograph 2: Exit to culvert.

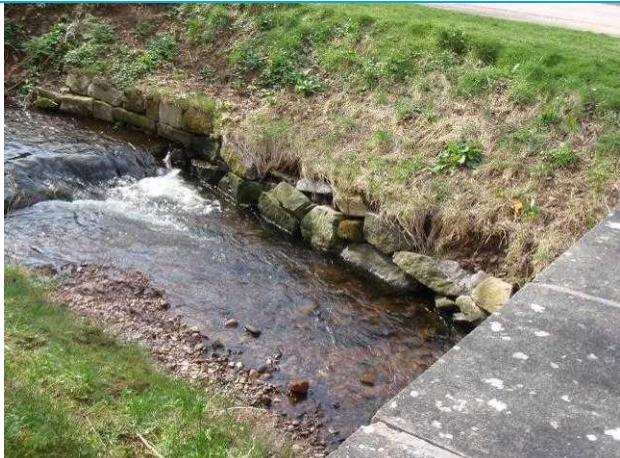
Photograph 1: View of wall.

Description	Bank alongside access road.
Anticipated Ground Conditions	Sand & Gravels.
Potential Ground Investigation	Type In situ SPT's, Soil grading Access Good
Structural comments	Bank showing signs of rapid erosion, could endanger adjacent access road.
Design considerations	
General condition	Slope natural and unreinforced. Condition only unacceptable if rate of erosion threatens economic loss.
Remedial action required	Bank may be reinforced to slow erosion.

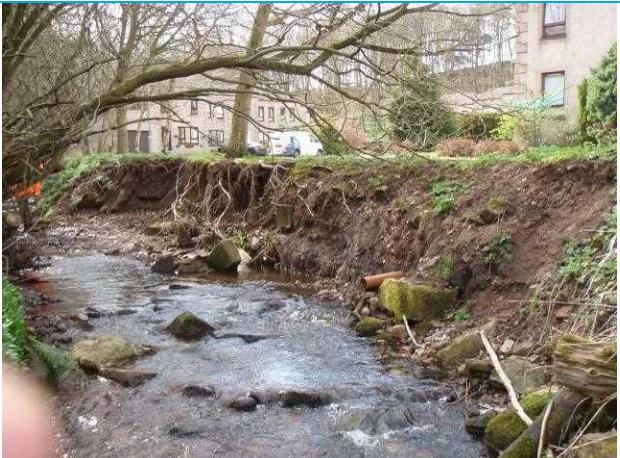
Photograph 2: View of bank.
