# Gardenstown Landslide Newsletter – March 2018

## Landslide Development

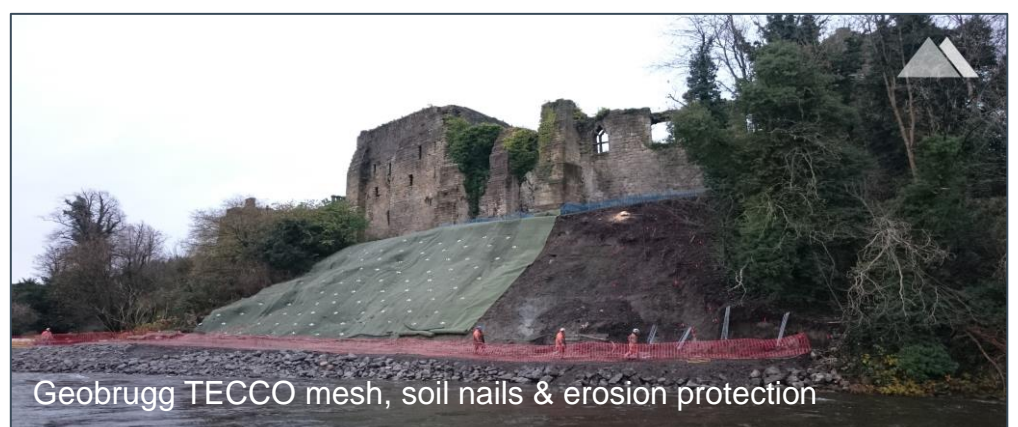
Completion of the temporary works will allow the ground investigation to be completed. Once all investigation has been reviewed, a stabilisation design, currently considered to comprise soil nailing and meshing will be designed and installed. The stabilisation will be undertaken from the top of the slope, down to road level.

These measures will be implemented in conjunction with a scheme to manage the flow of groundwater and surface water away from the landslide area.
