**Area :** Banff and Buchan

**Parish :** Pitsligo

**Kirkyard :** Peathill old Kirk.

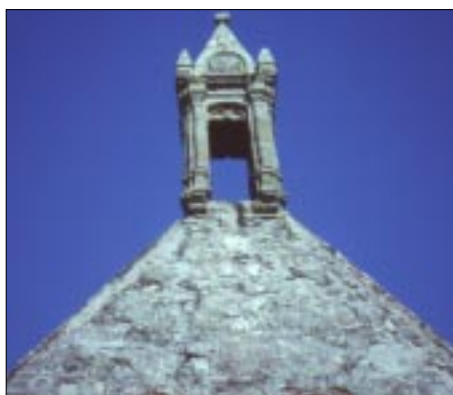
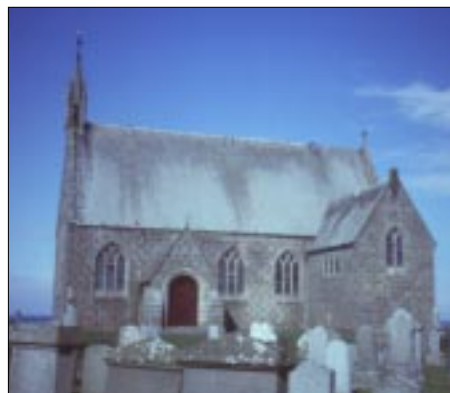
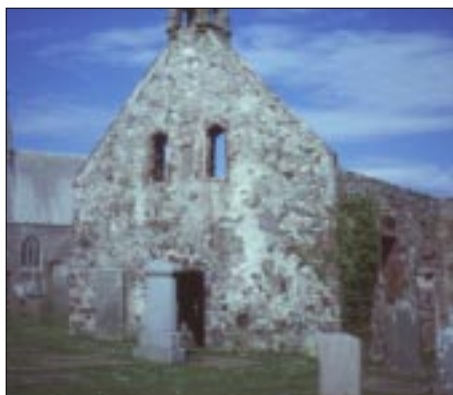
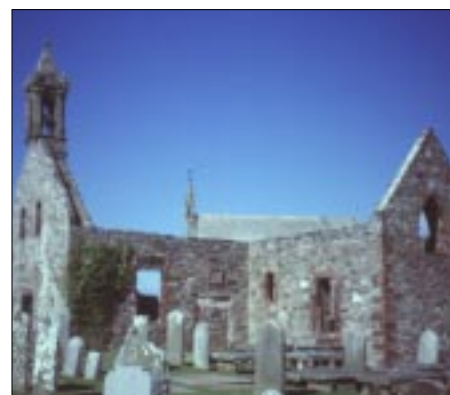
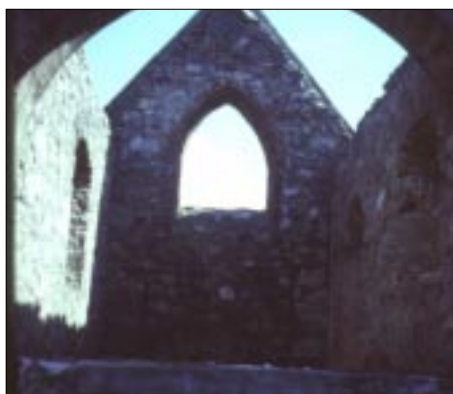
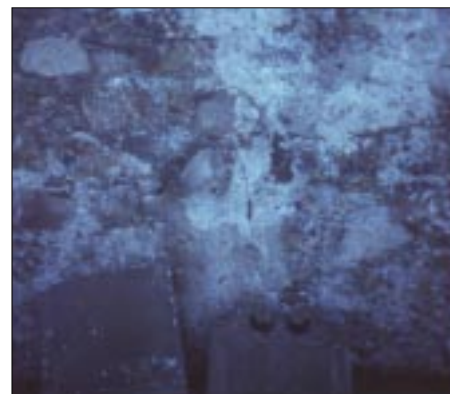
**The old Kirk :** The old kirk, built in 1632 with the S. aisle added in 1634, (this being commemorated by a well-carved plaque bearing the initials A. L. P.), is of a T-plan composed of rubble walls with dressed red sandstone margins. The entire kirk is in dire need of being re-pointed and possibly re-harled throughout. The thin layer of debris above the Forbes of Pitsligo mausoleum must be removed and the fine arch above cleaned of all weeds and its top surface consolidated, though the mausoleum beneath appears to be in good order. The ivy on the S. wall of the main aisle needs to be checked soon and a very serious crack on the W. wall also requires remedial work.

The bellcote and gable wall need the most urgent attention, though the bellcote still exhibits a very high calibre design, with strap-work pyramidal finials rising above clustered columns and terminating in a shaped ball finial. The finial is now shattered badly with the entire structure leaning visibly to the north.

The old kirk is in need of a considerable amount of structural work to ensure that its fabric is preserved: all of the major problems being listed above. Of extreme urgency is the belfry.

All of the recumbent stones need to be carefully brushed to remove layers of moss and grass cuttings.
