Area : Banff and Buchan

Parish : Banff

Kirkyard : St. Mary's Kirk.

N.G.R. : NJ 688 643

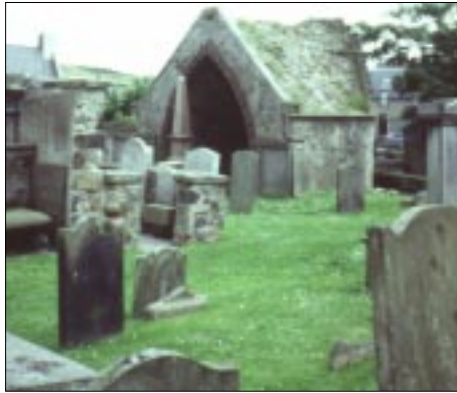
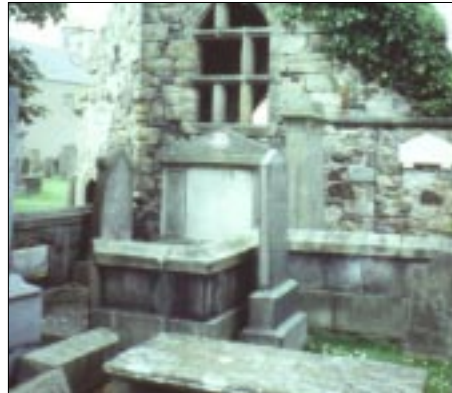
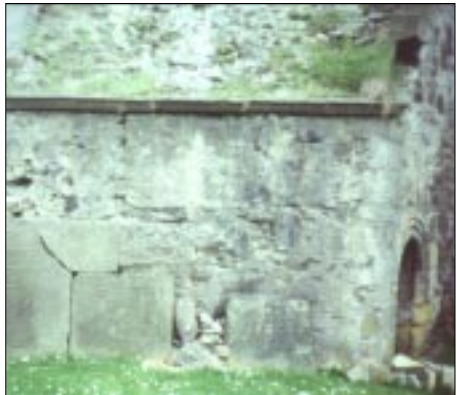
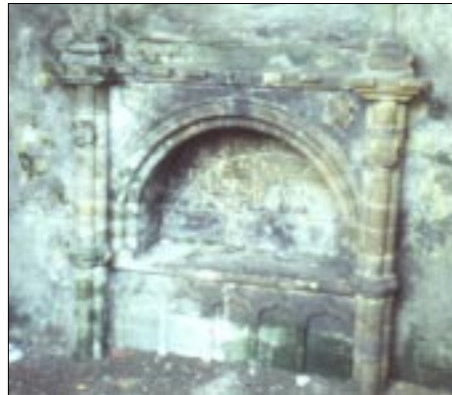
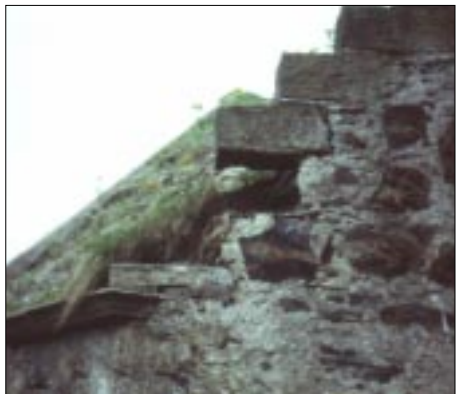
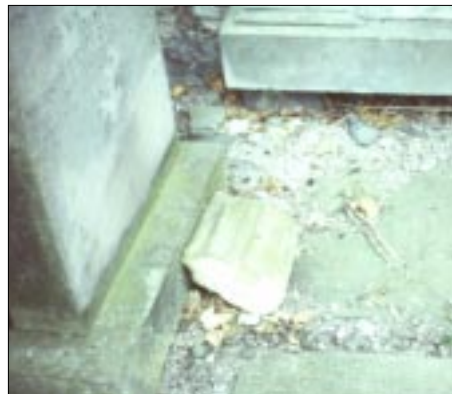
Boundary wall and gate piers : To the r.h.s. of the gateway, the wall has developed a large crack running the entire height of the wall which will need to be rebuilt very soon. The gates themselves are rusting badly and in a dangerous state. The iron railings are in good order though they are in need of being repainted and a section to the r.h.s. of the gateway replaced.

The old Kirk : The old kirk of Banff was erected in 1471 and demolished in 1797, the partially reconstructed 16th - century "Banff Aisle" is all that remains. The roof of this structure is in dire need of being cleared of weeds and re-pointed, and the two crowsteps that have recently fallen put back. One of the mullions from the stone mullioned window is lying on the ground in front of the aisle and must be restored to its original position before it is lost. Internally the aisle is now the enclosure of the Ogilvy family with stones dated 1558 and 1580, all suffering badly from the effects of spray paint and vandalism.

Tombstones : There are approximately 220 table-top and recumbent tombstones of which 48 are significantly decorated, with many hundreds of upright stones dating from the 16th - to the 19th - century. There are amongst others, a fine recumbent figure tomb, an exceptionally well-executed pyramidal tomb with a white statuary

marble tablet carved in relief, and a superb 1692 Renaissance memorial complete with Corinthian columns and trumpeting angels, though the relief lettering is badly eroded.

The old kirk is in need of urgent and sympathetic repairs to all of the above noted flaws, not least of all the complete removal of ivy from the S. flank of the aisle. The majority of the monuments need surface joints re-pointed to ensure a good and continuing state of repair and preservation. The problem of vandalism needs to be monitored.
